INVESTIGATION OF RECLAIMED DRILL SITES, PEBBLE PROSPECT, 2016

**Center for Science in Public Participation
for
United Tribes of Bristol Bay
304 Main Street
Dillingham, AK 99576
November 3, 2016**

Please cite the report as: Zamzow, K and D Chambers. 2016. Investigation of Reclaimed Drill Sites, Pebble Prospect, 2016. Kendra Zamzow, Ph.D., and David M Chambers, Ph.D., P. Geop., Center for Science in Public Participation, Bozeman, MT, for the United Tribes of Bristol Bay, Dillingham, AK, October, 2016.

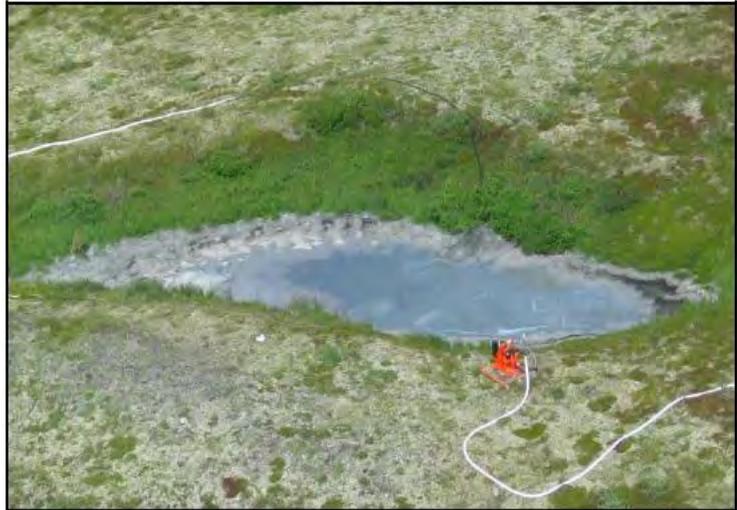
Photo #14. Clay deposited in a dry depression by discharged drilling fluids.

Figure 1. Drilling waste discharged to land. Kettle ponds are small bodies of water in depressions; some are connected to groundwater while others are not. Large pumps move water uphill from the sump approximately 1000 feet to upland ponds (DNR inspection report June 2005), such as the one shown in this photo (DNR inspection report July 2007).

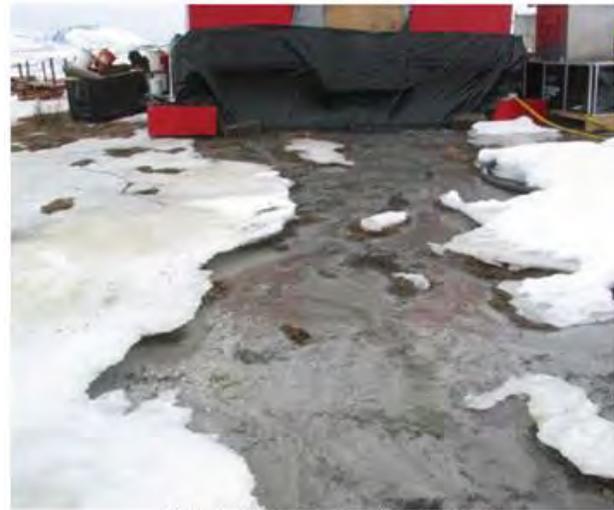
Figure 4. Water and cuttings discharge on uplands.

Figure 3. Water and sediment from the drill cuttings was discharged as permitted onto the uplands directly from the drill rigs. During ice free months a sump pit will be dug to retain drill cuttings. (DNR inspection report, April 5 2007)

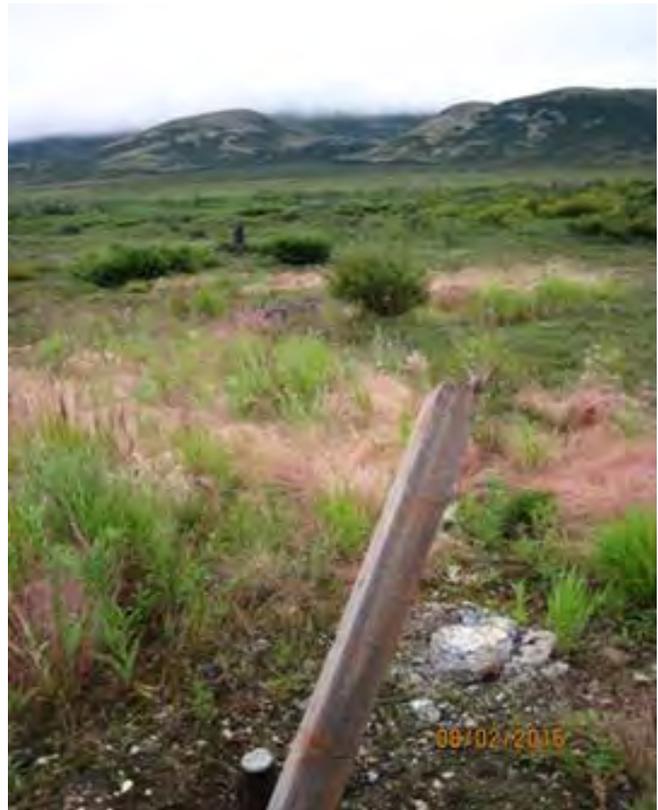
Dead vegetation was one of the most common sightings. Additionally some sites had “squirrel grass” (species not known) identified by a local resident as not native to the area (Figure 7). At site DDH 11533 it appears to be spreading downwind from the original site of application. These sites also had areas of dead vegetation, indicating that non-natives were applied when natural vegetation failed to re-establish. There is also a note in the August 2010 Field Inspection report that Kentucky Bluegrass was seeded at DDH 8417 to control erosion.⁷

Figure 7. Squirrel grass. Reddish-colored grasses in foreground and center.

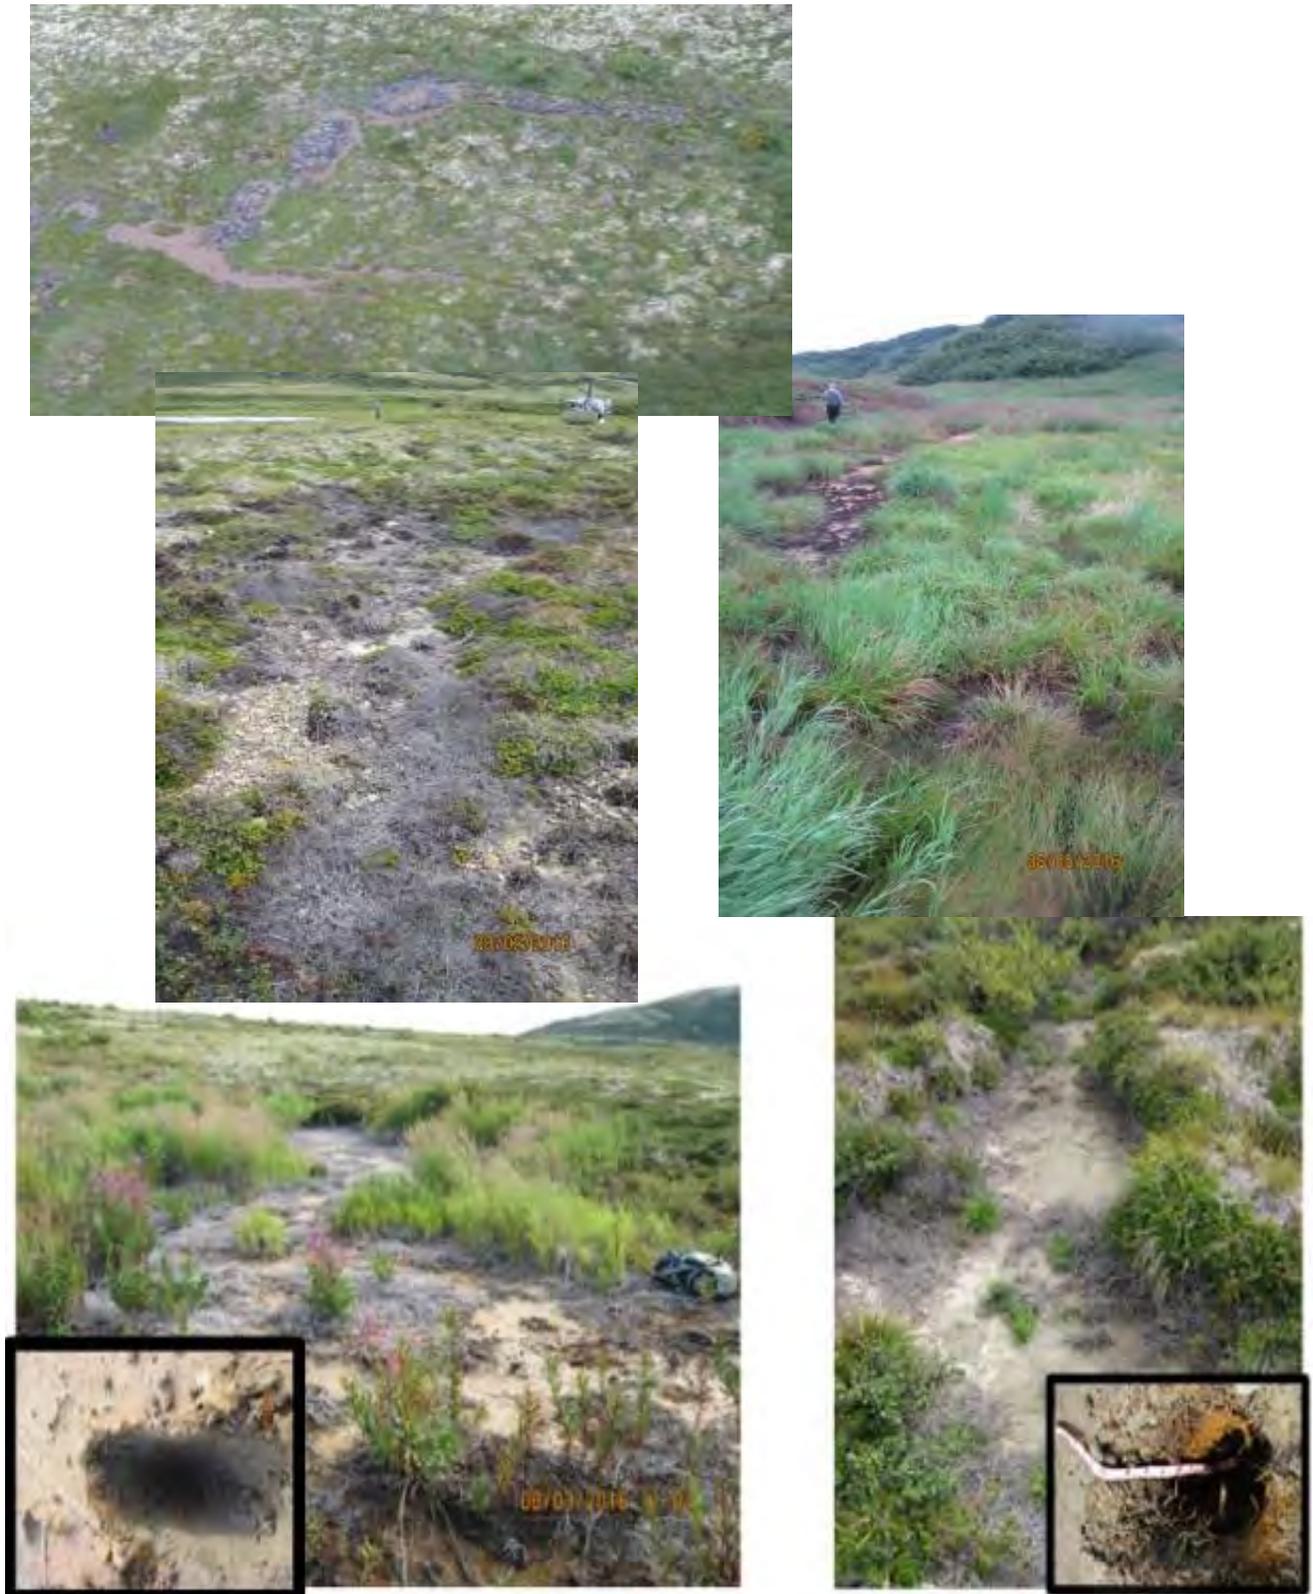
At several sites tundra mats placed on sump pits failed to grow, vegetation did not establish on overburden on sumps (Figure 8), or vegetation was failing to thrive as evidenced by dead patches. The October 2012 field inspection report by ADFG noted that “*stockpiled squares of tundra mat on-site were desiccated, overturned, broken and flaking apart, and scattered by the wind with no apparent effort to cover or protect them*”. Tundra mats may be failing to thrive due to poor handling, soil quality, or a combination.

Drill casings had been, and potentially still are, periodically flushing material onto the surface. At these sites, fine-grained orange-yellow or grey material presumed to be drill cuttings were present in a trail leading from the casing downgradient. Cuttings directly covered vegetation (tundra mats) and killed vegetation in the path of the trails. In some areas, drill cuttings had been apparently discharged over a wide area, and were evident as patches of cuttings and dead vegetation, particularly in depressions. Impacts from cuttings are distinct from locations where vegetation did not re-establish on drill sumps and trenches (Figure 8).

Figure 8. Vegetation impacts. (Top) Vegetation failing to grow on sumps at DDH 11540. (Middle) Drill cuttings flushed from open casings at GH05-60 (left) and DDH 7392 (right). (Bottom) Landscape and soil profiles of drill cuttings where drilling waste has been discharged over large areas near DDH 6355 (left) and DDH 12548 (right).

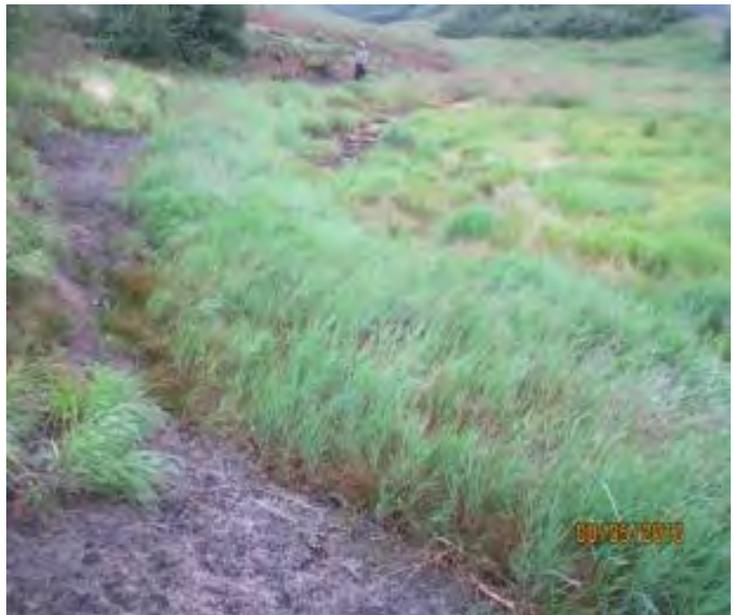
There is also a ring of dead vegetation several feet above the floor of the gulley (Figure 10). There is no obvious explanation for this, but it is possible that several drill sites disposed of waste in the gulley, affecting vegetation. Based on mapped information, a stream was

Figure 10. Dead vegetation along hillside in gulley. Acid drill cutting can be seen in the background in the bottom of the gulley, where they have flushed from DDH 7392.

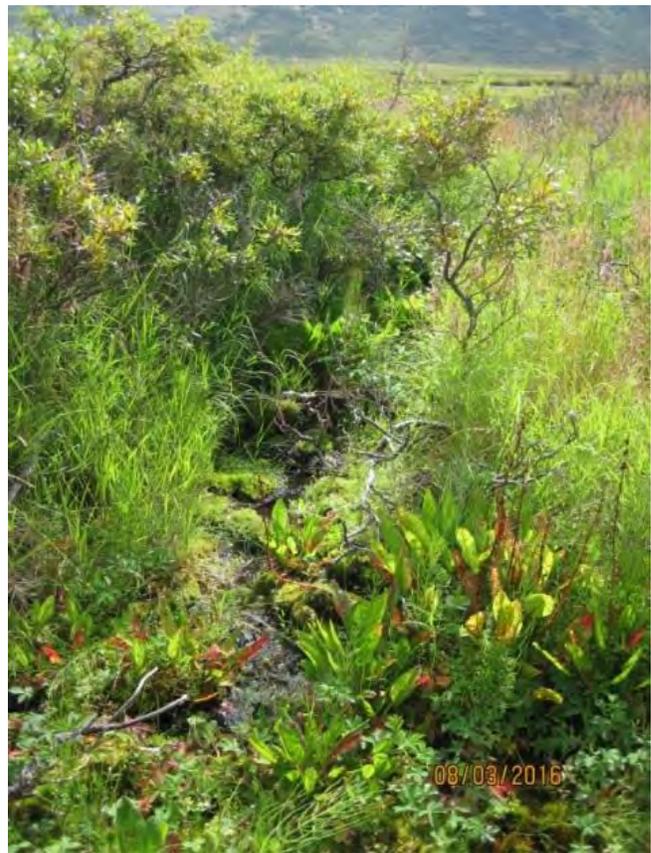
In 2011, water at site DDH 11540 was sampled at the drill sump and in a wetland pool and spring downgradient.¹⁴ In 2016 sump material, a wetland spring (Figure 11), and wetland sediment were sampled. The sump material was collected as a core with 1 inch of overburden and 6 inches of a blue-grey material (sump pit contents) that swelled when removed from the pipe. The wetland spring was a small, clear spring downgradient of the sump site, in heavy brush and slightly to the southeast about 80 feet (estimated). The 2011 spring is described as 98 feet downgradient.

The wetland spring in 2016 had the same pH and conductivity as the 2011 sample, but was elevated in minor and trace elements relative to the 2011 sample, although lower in concentrations than the 2011 wetland pool sample. Concentrations of cadmium (not shown), barium (not shown), and zinc were similar to 2011, but copper, molybdenum, aluminum, iron, manganese were higher than in the 2011 spring sample and higher than ponds 715' and 915' upgradient (USGS 2008) (Table 10).

Figure 11. Wetland spring sampled in 2016.

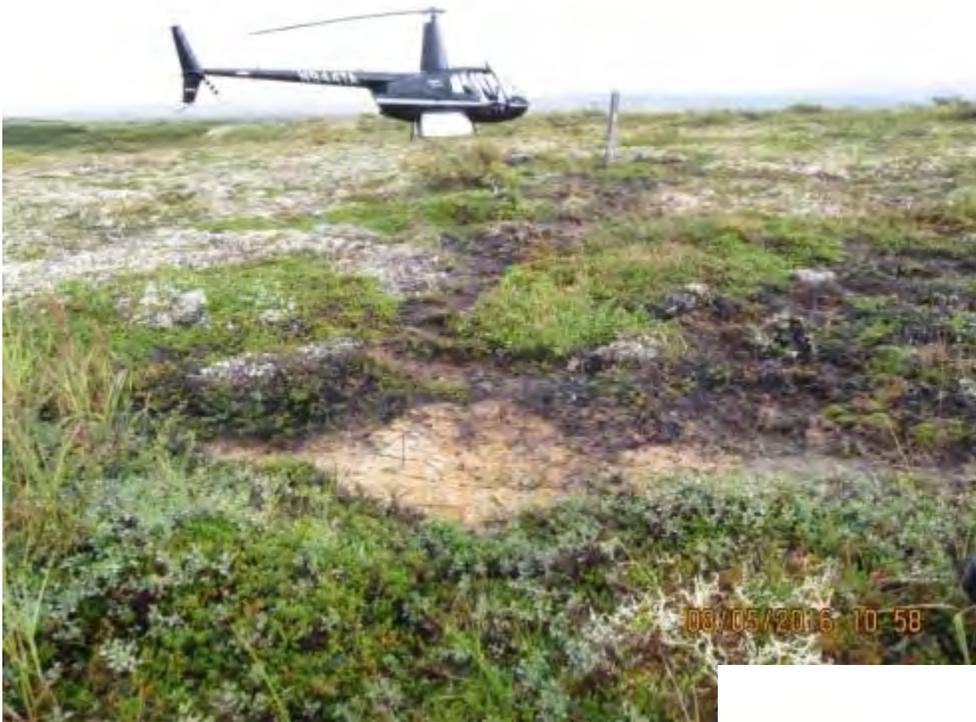
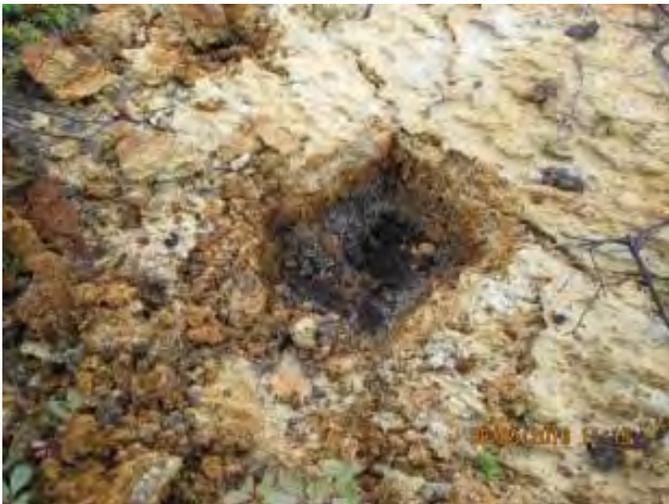
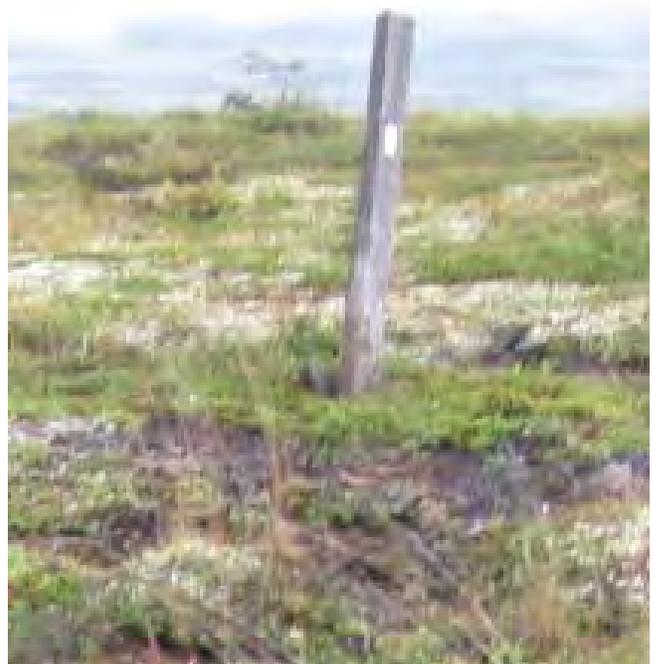
DDH 3129

Drill cuttings flushed from this low, cut off, open casing towards a pond. A thick layer of cuttings is shown in the photos. Cuttings were acidic with elevated sulfate, arsenic, copper, and molybdenum. Pond water did not have high concentrations of analytes; pond sediment was not collected.

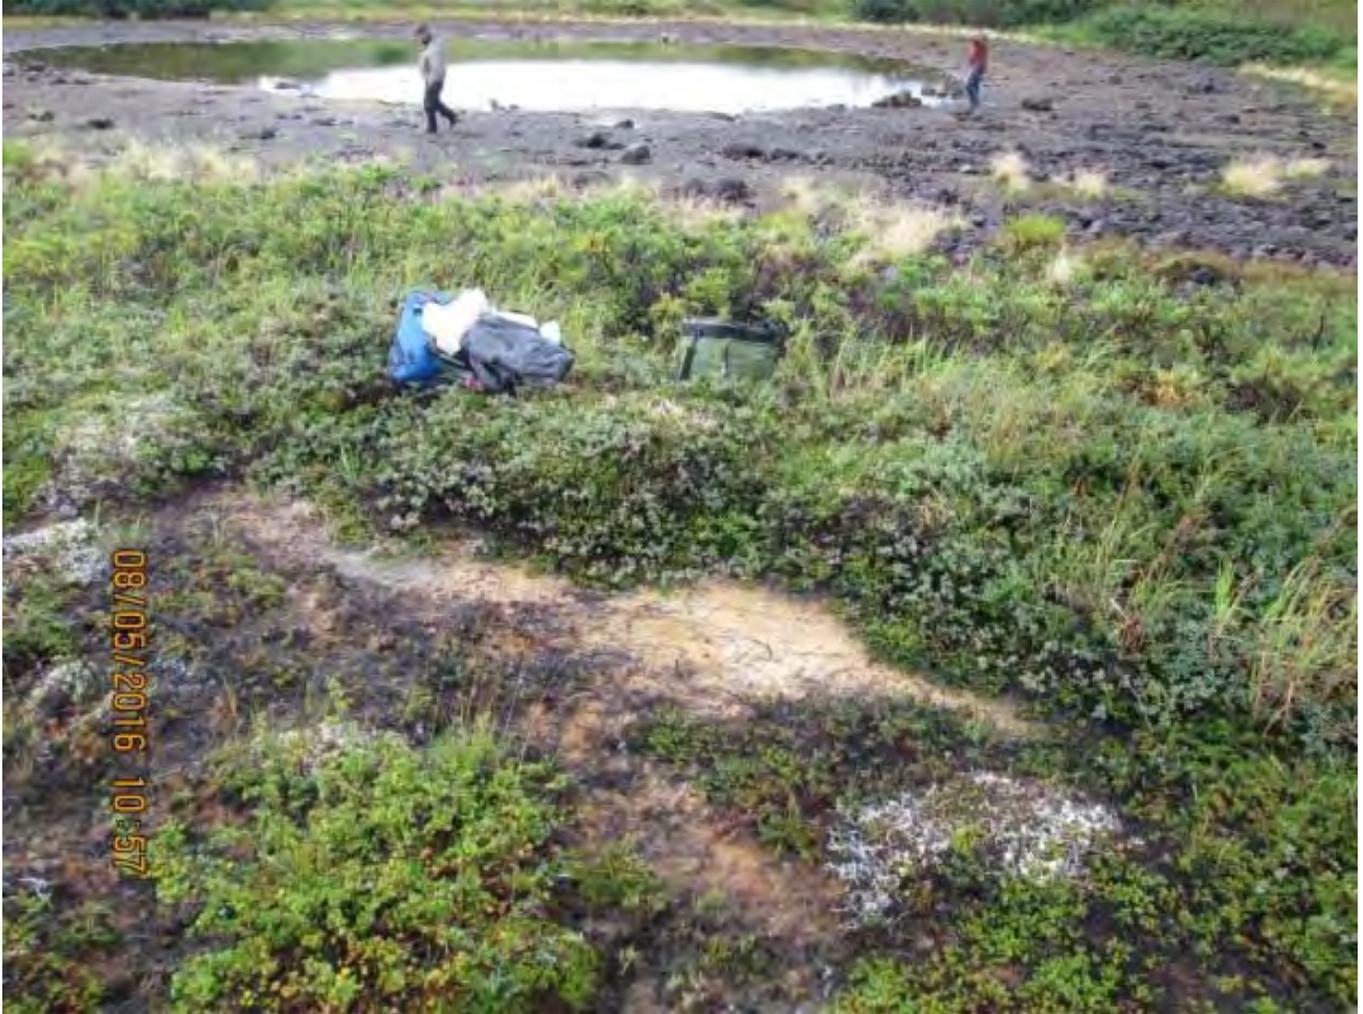
The pond downgradient from DDH 3129 did not have elevated metal concentrations, with the exception of slightly elevated aluminum. Sediment was not collected.

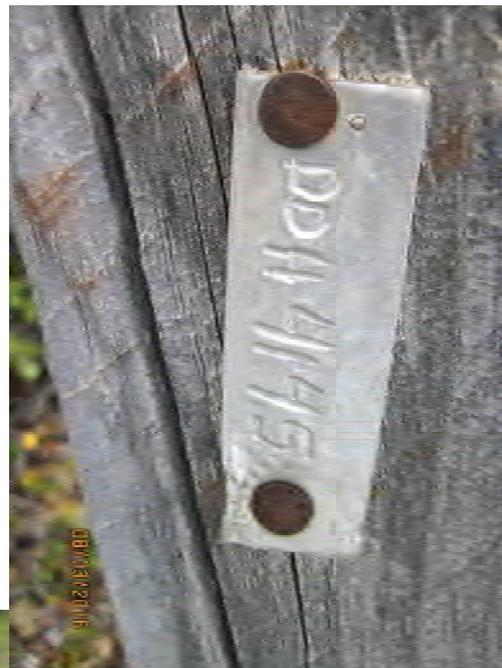
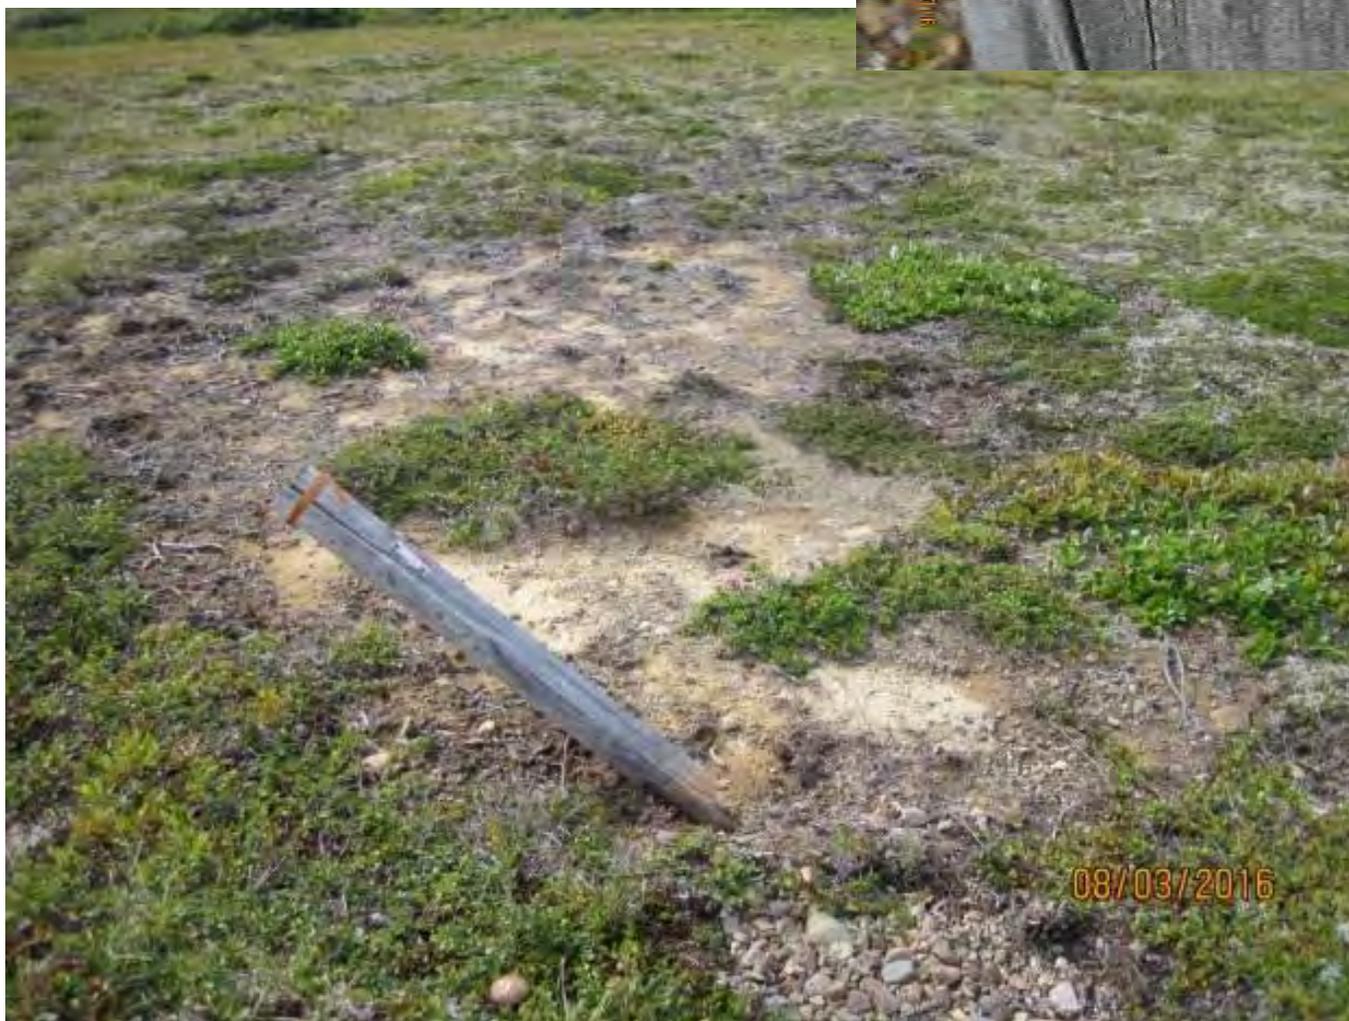
DDH 4145

This site is one of at least six within walking distance of each other. It is a good example of cuttings flushed from a drill casing.

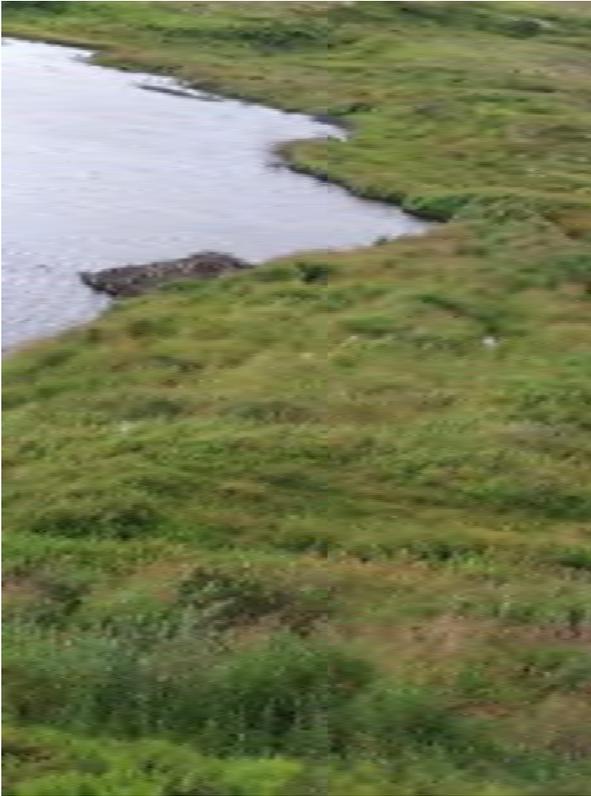
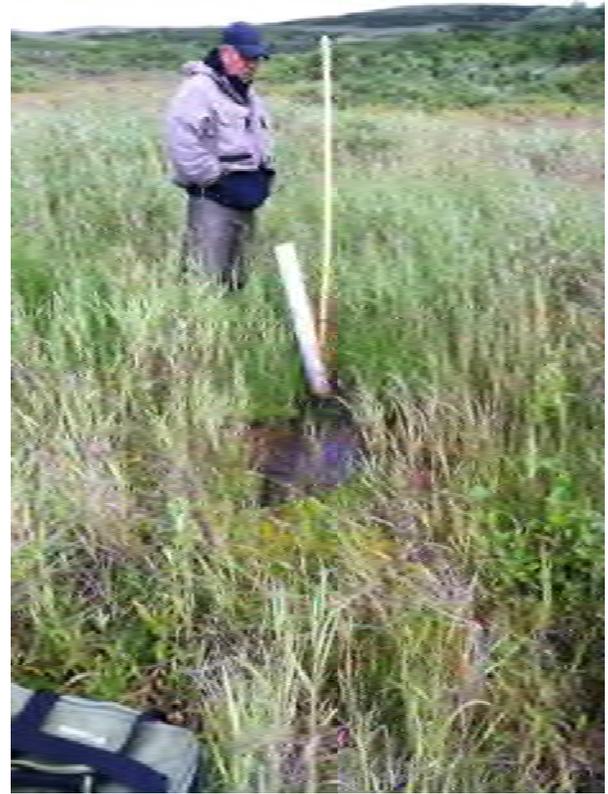
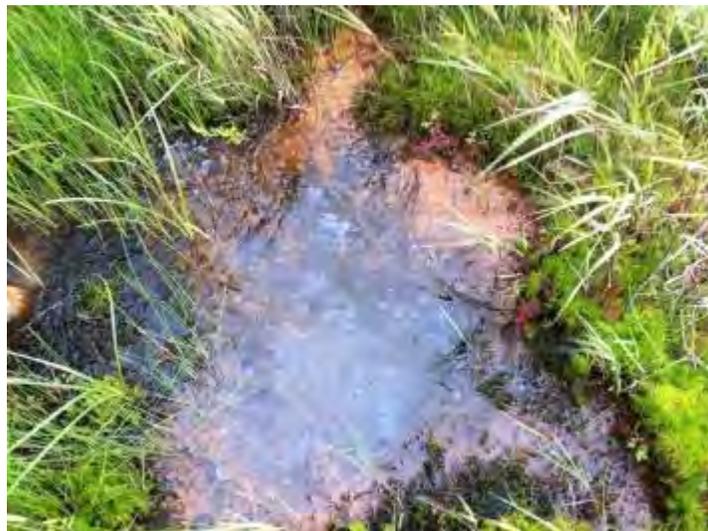
This site is located in a wetland on the edge of a beaver pond. You can see the weathered orange snowpole marking the site in the picture on the left. To the right, outside of the picture, is a wetland pond that had iron staining. Water directly around the drill casing at DDH 4202 also had iron-stained water and a sheen. This is not uncommon in wetlands, so we collected water and sediment samples at the base of the casing. Iron and sulfate were elevated in water samples above water quality criteria and above water samples collected in the pond in 2008 (sulfate at 35 mg/L vs 11 mg/L and iron at 2.7 mg/L vs 0.6 mg/L). Sediment was very high in copper (1,892 mg/kg) and molybdenum (246 mg/kg). This information suggests that the standing water around the drill casing is artesian flow from water passing over mineralized ore in the drill hole, rather than natural wetland water.

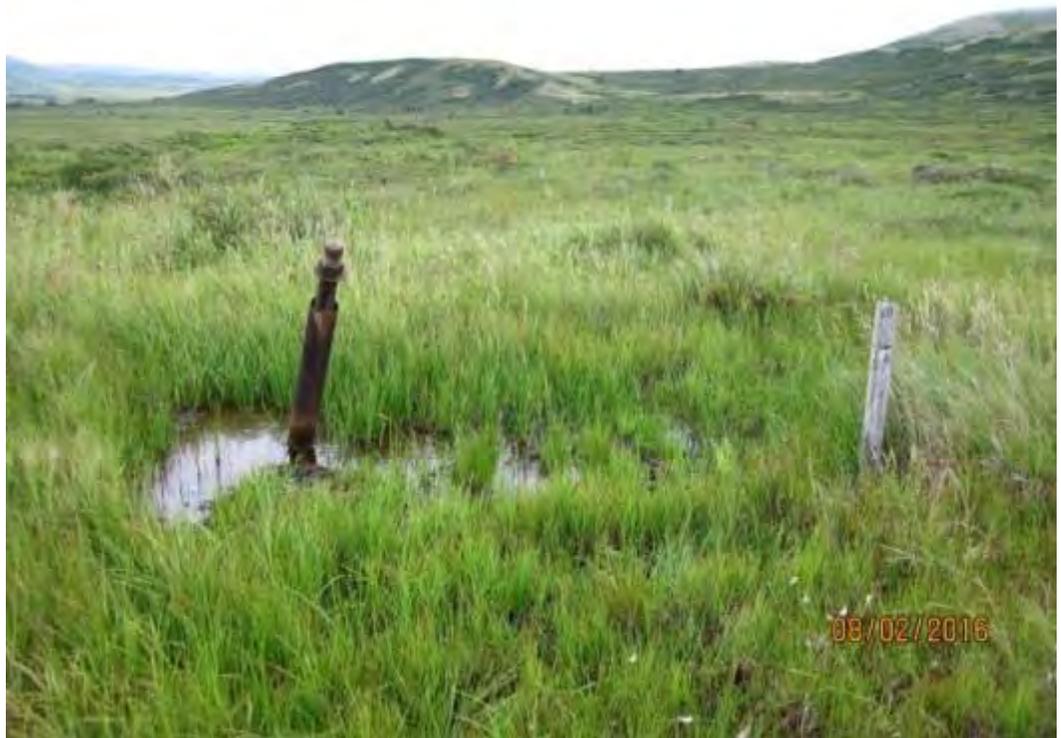
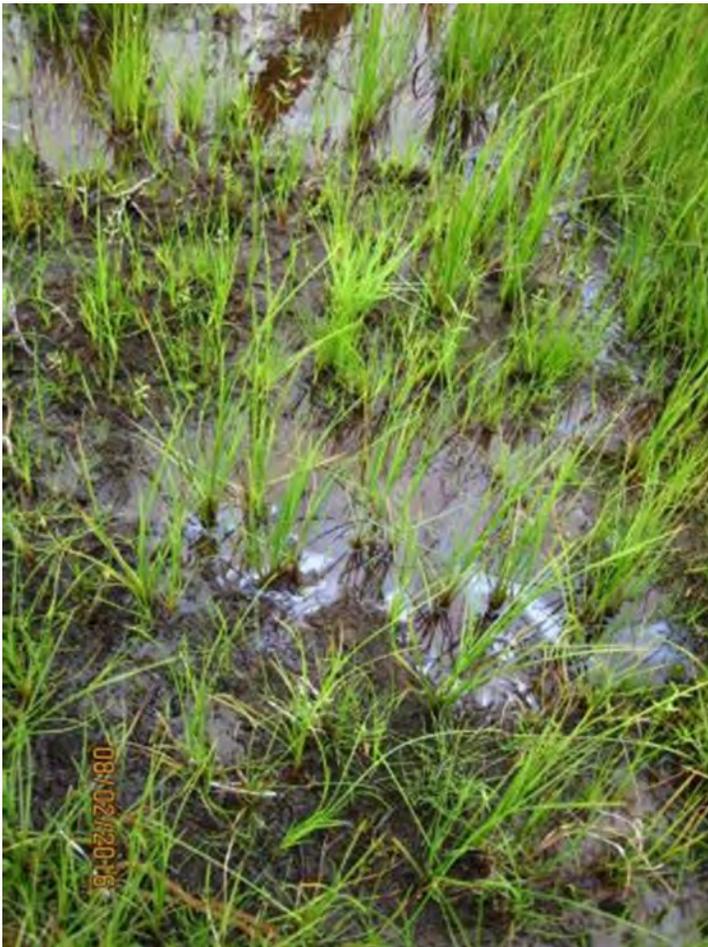
DDH 5330 is in a wetland and surrounded by standing water. Water and sediment samples indicated that water is coming up from the casing. Although water was low in copper, sediment had elevated copper at 621 mg/kg; the highest background sediment copper in the mine area was 200 mg/kg, with nearby sites less than 20 mg/kg. Sediment was also enriched in molybdenum (98 mg/kg vs a maximum of 22 mg/kg in mine area sediment). This site was listed as a drillhole “converted to active” well although there are no indications that it could be used as a water source.

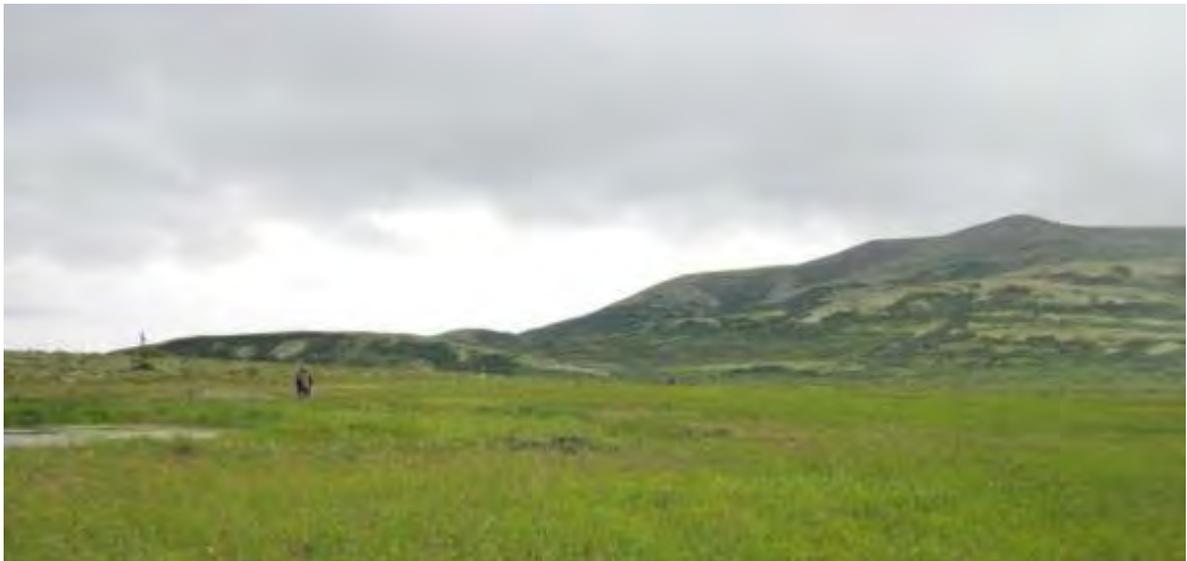
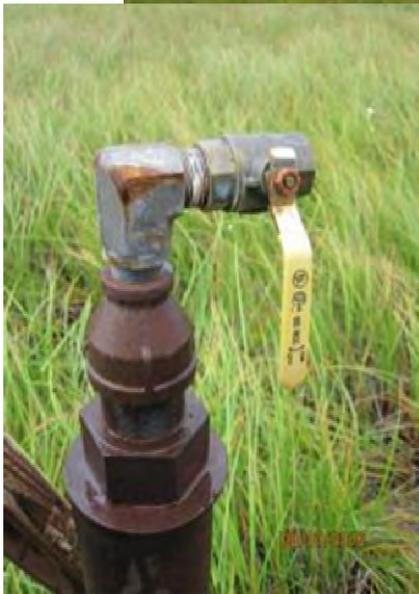
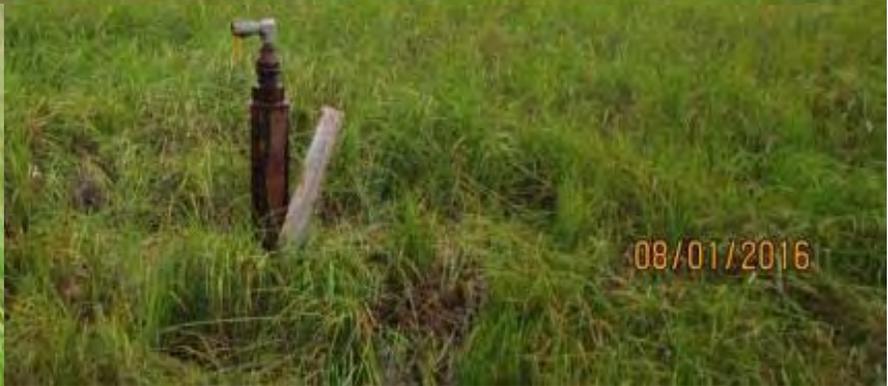
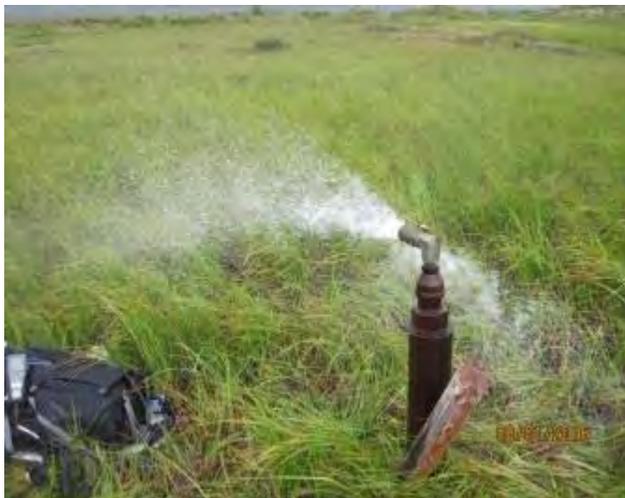
The entire plateau where this drill site is located is wet with springs. The drill site has a history of artesian conditions; USGS observed free-flowing water from the drill stem – and collected a sample – in 2008. The casing currently has a valve on it, but this will require regular maintenance. A similar site, DDH 7379, had a broken valve and artesian water. DDH 7365 is near a pond (to the middle left of the photo). Standpipe (also called drill stem) water was collected by opening the valve. It is elevated in sulfate, sodium, copper, iron, manganese, and lead (report Table 11 and unpublished).

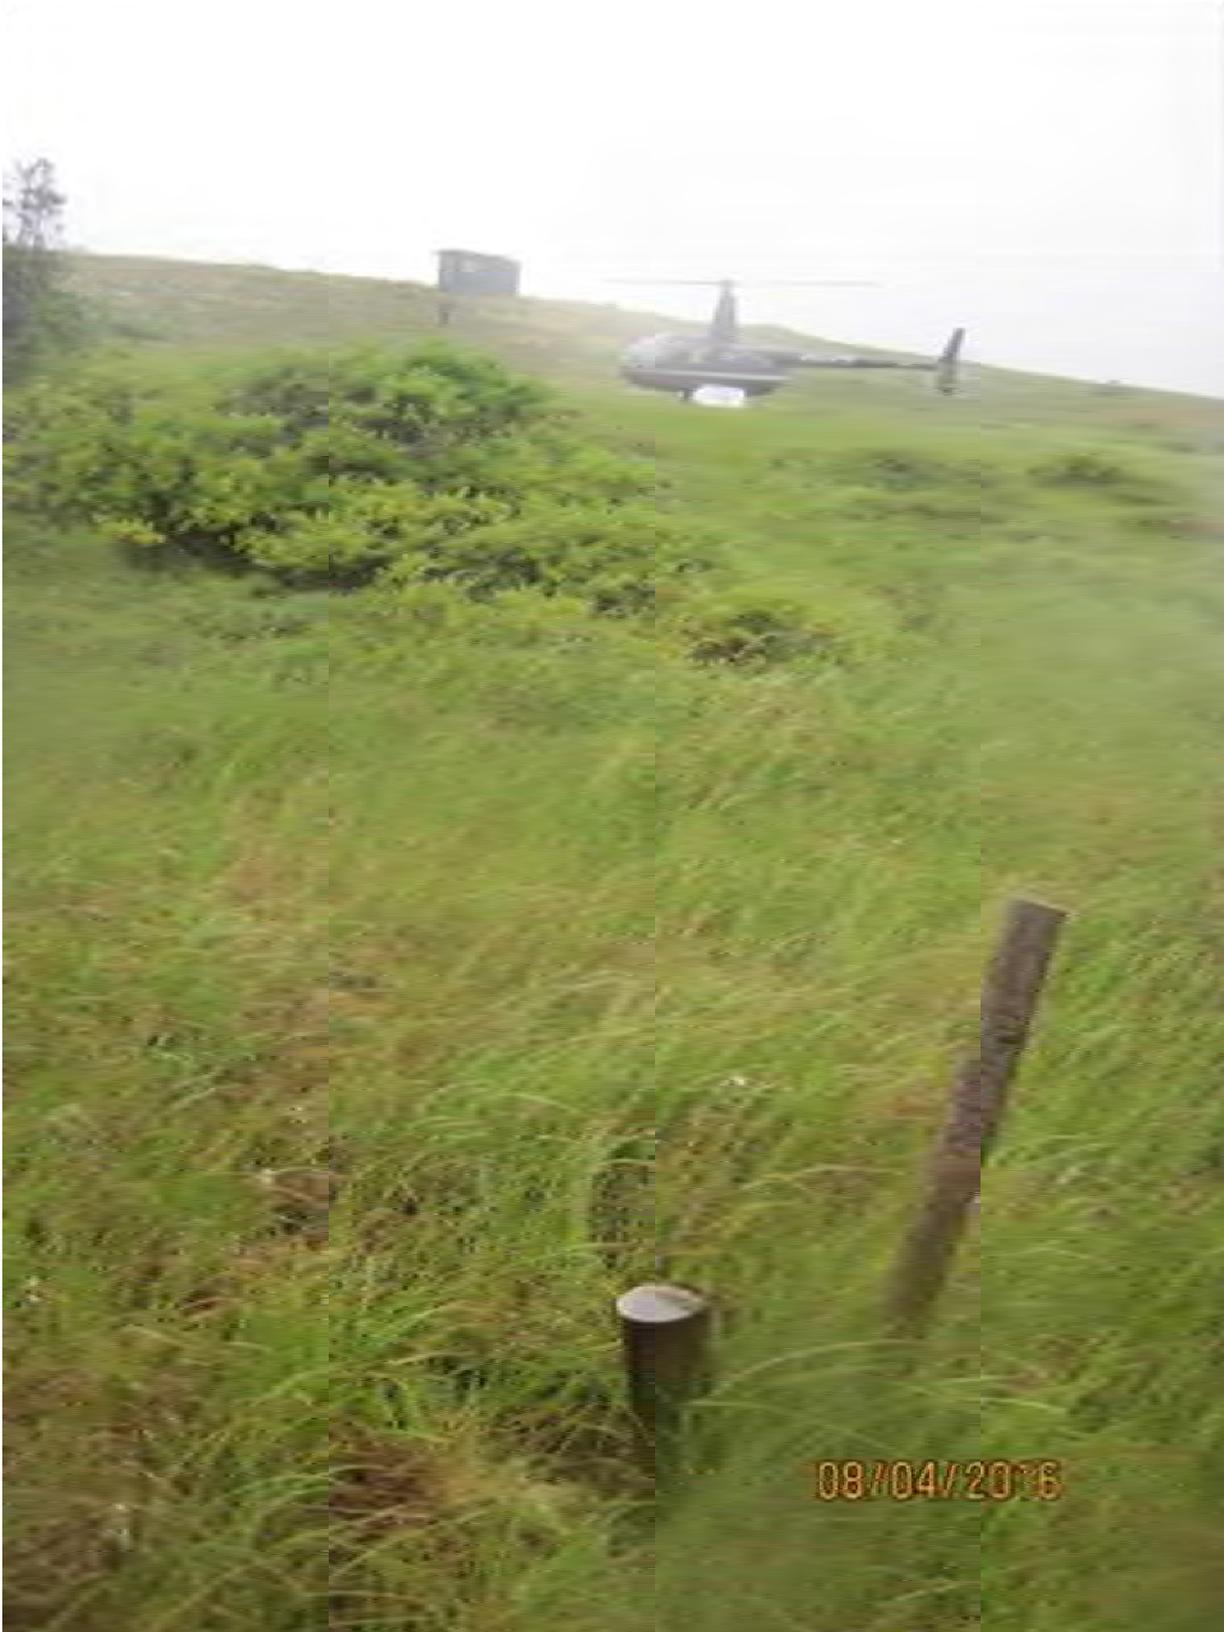
DDH 7367

One of many examples of an open casing.

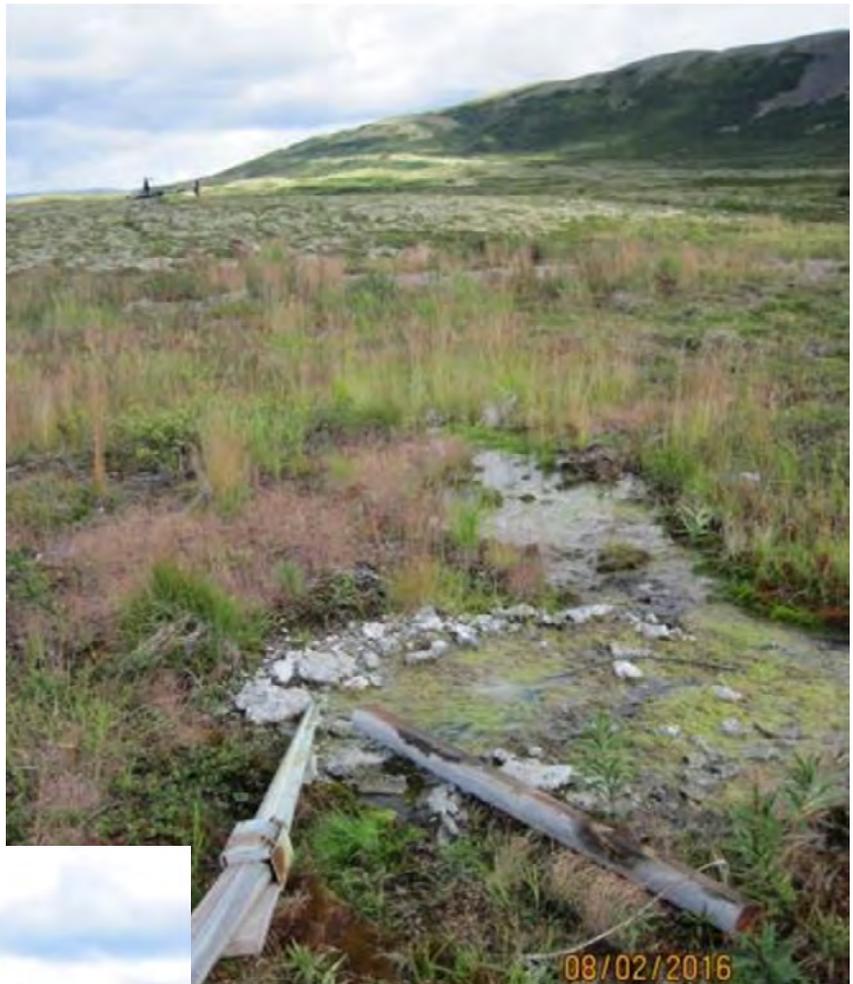
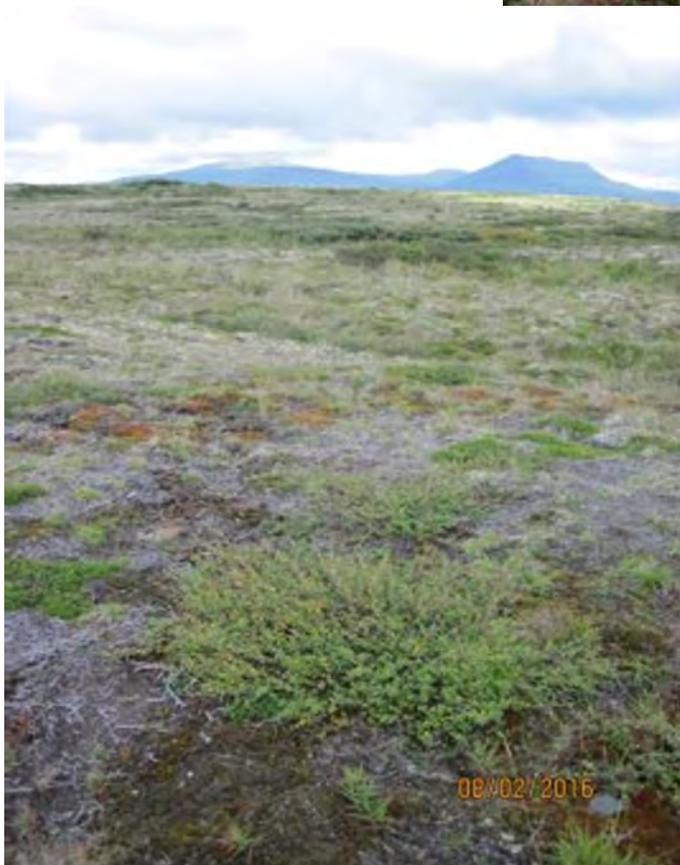
DDH 7380 & DDH 7386

This site is an example of wetland contamination and of the need to inspect and correctly classify drill sites.

These should be separate locations, and have two different reclamation classifications. DDH 7380 is classified as fully reclaimed and stable (3E) and DDH 7386 is classified as inactive and stable (2E). Monument markers for both posts were lying next to an artesian flow upwelling from where a drill casing had been removed. There is no record of DDH 7380 having been inspected by the State, and DDH 7386 appears to have been last inspected in October 2007.

At this site, clear water bubbled up through milky material, possibly cement. The site had a slightly alkaline pH (7.8) and was elevated in copper, aluminum, iron, and manganese, and several other elements, including thorium and uranium (report Table 6). Only DDH 7382 and DDH 7380/7386 are elevated in thorium and uranium; it is possible that both are moving through alkaline material. There were several patches of dead vegetation in the general area.

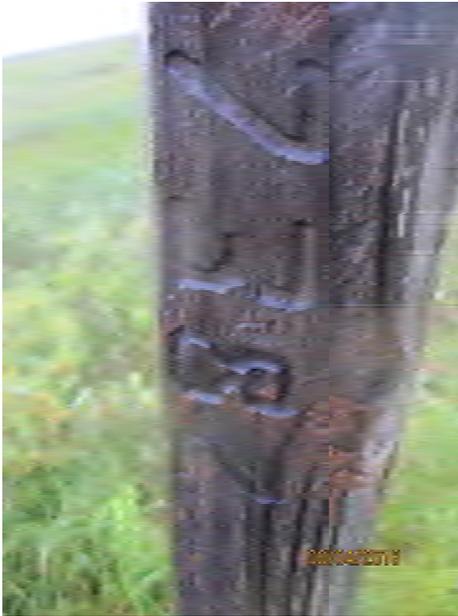
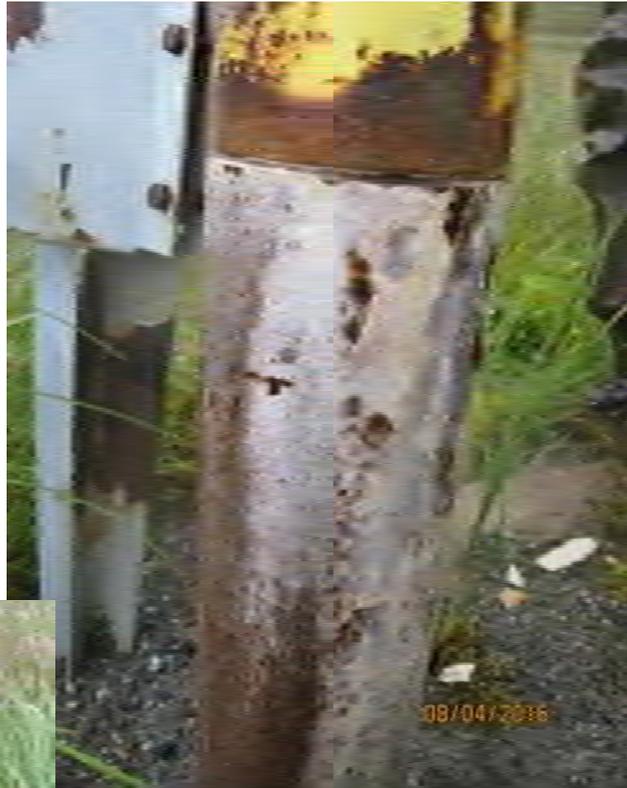
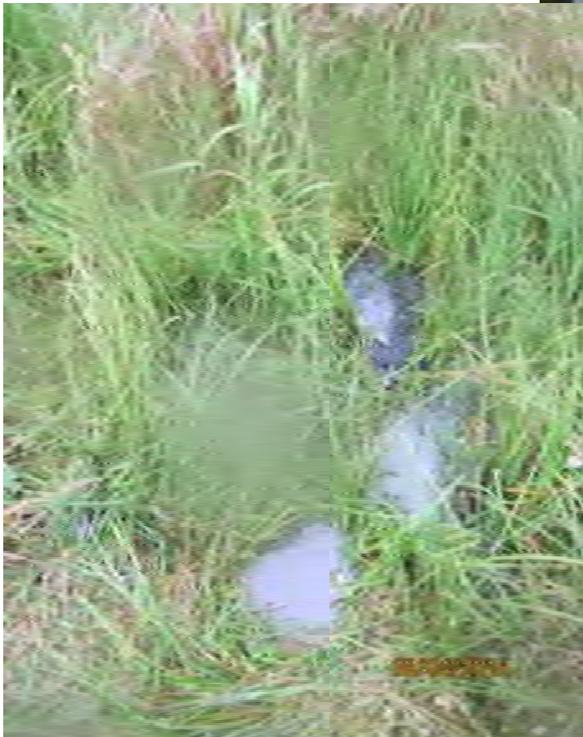
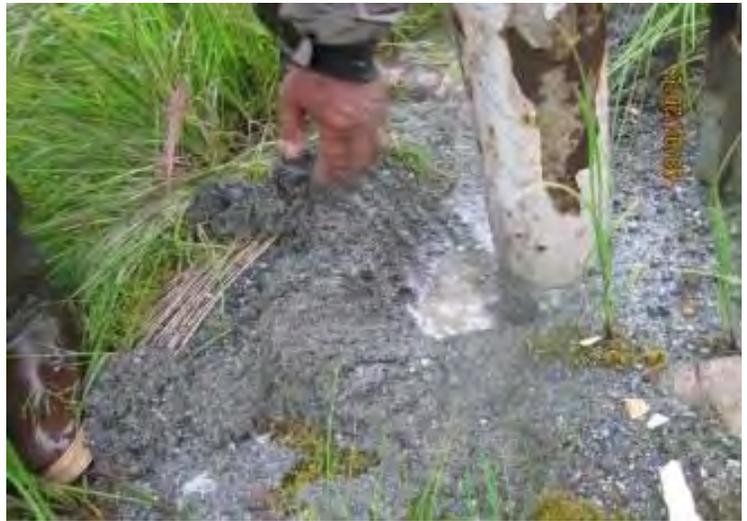
This site was visited during a rainstorm. Gravel was packed around the casing, which was unusual, and a milky fluid was welling up from around the casing in the gravel. It was observed moving into a wetland. Samples from material around the casing, wetland water, and wetland sediment were submitted for laboratory analysis. The wetland sediment was contaminated with petroleum; it was one of only two samples that had petroleum contamination. Possibly the petroleum came from the material packing around the casing. Wetland water and sediment were elevated in copper; water was also elevated in several different metals (report, Table 11). Photos show the casing and the trail into the wetland.

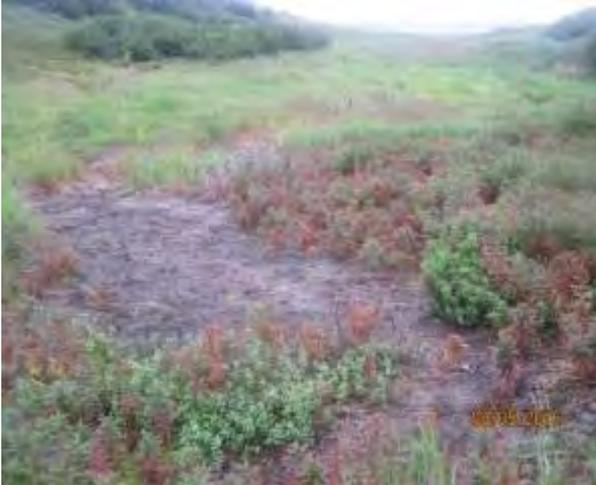
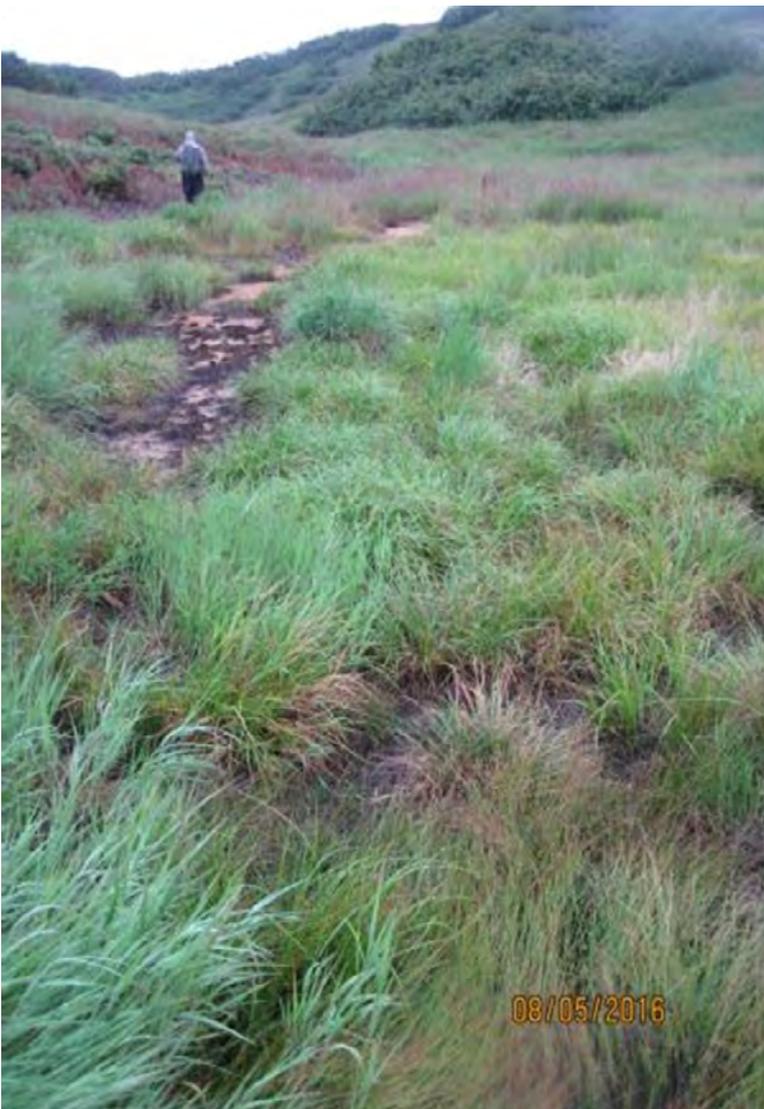
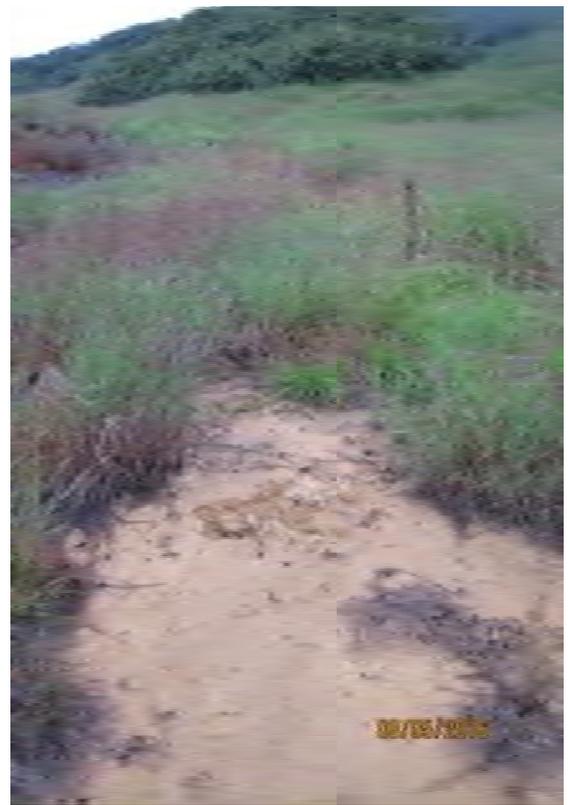
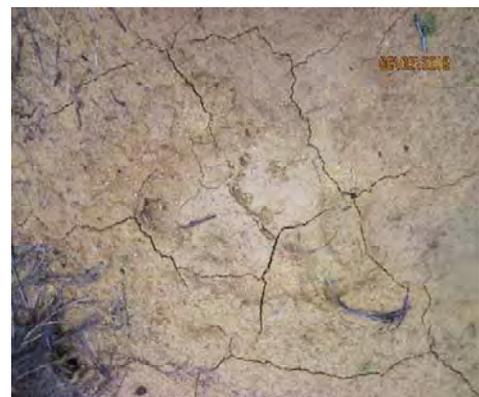
To the west of the discovery outcrop is a horseshoe-shaped rim of hills around a gully. Around the rim are several old drill sites, with sites DDH 3071 and DDH 7392 in the gully about 20 feet apart. A thick layer of drill cuttings (bottom right) ran from the open casing at DDH 7392 for well over 100' (bottom left). No water was present at the site, but given the path of the cuttings it is feasible that rainwater or snowmelt is moving the cuttings. The cuttings were light colored and about 4 inches deep, covering vegetative mat. The material was acidic (pH 3.0), with elevated specific conductance, sulfate, copper, and molybdenum (Report Table 8).
