INVESTIGATION OF RECLAIMED DRILL SITES, PEBBLE PROSPECT, 2016

**Center for Science in Public Participation
for
United Tribes of Bristol Bay
304 Main Street
Dillingham, AK 99576
November 3, 2016**

Please cite the report as: Zamzow, K and D Chambers. 2016. Investigation of Reclaimed Drill Sites, Pebble Prospect, 2016. Kendra Zamzow, Ph.D., and David M Chambers, Ph.D., P. Geop., Center for Science in Public Participation, Bozeman, MT, for the United Tribes of Bristol Bay, Dillingham, AK, October, 2016.

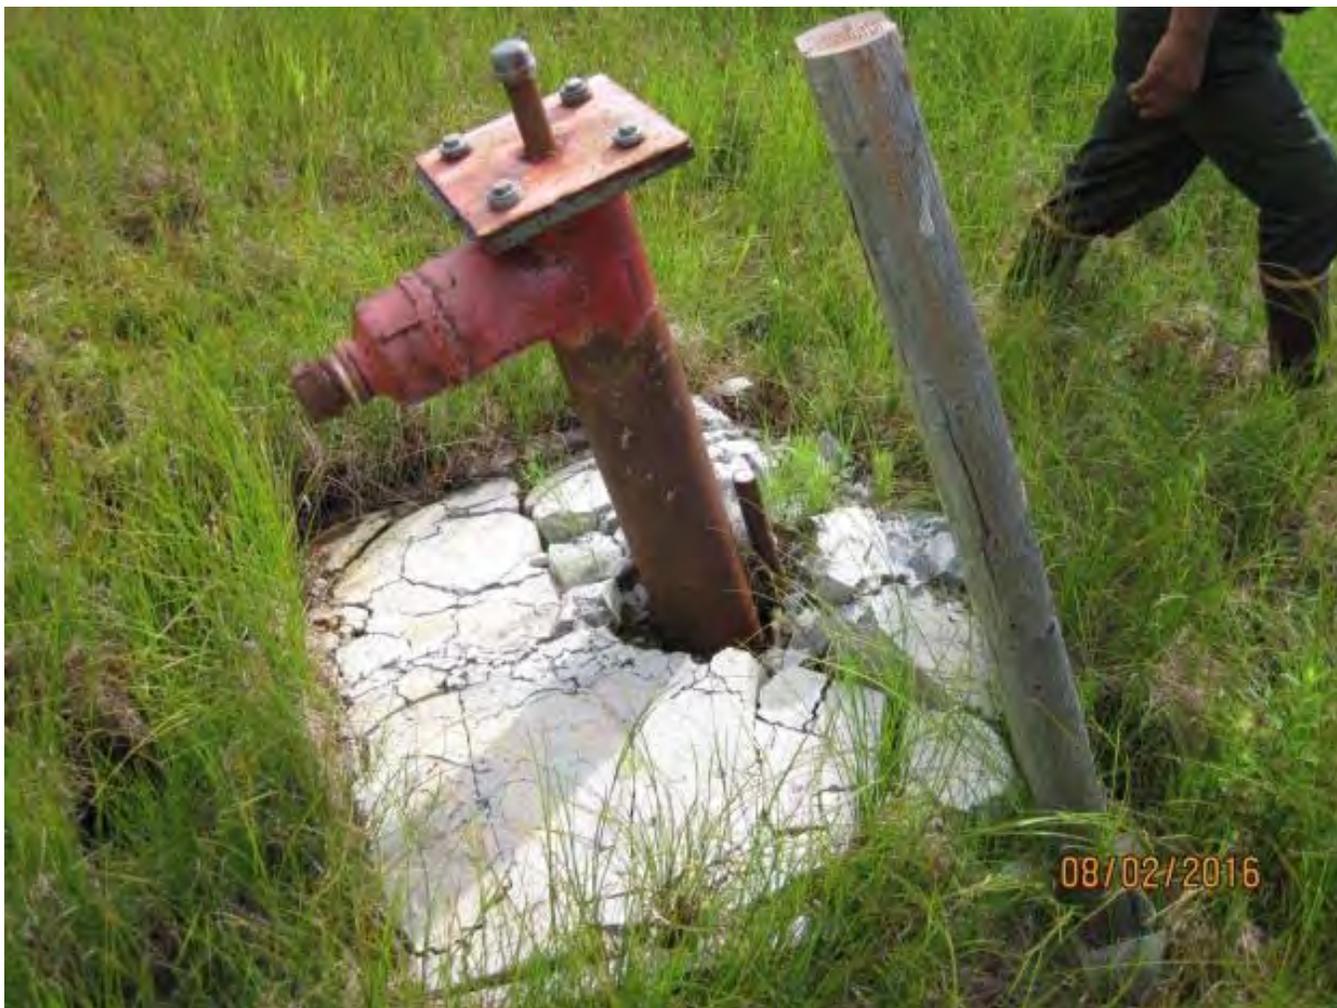
This site represents one of several casings with a variety of bolts and plugs, possibly to contain artesian conditions.

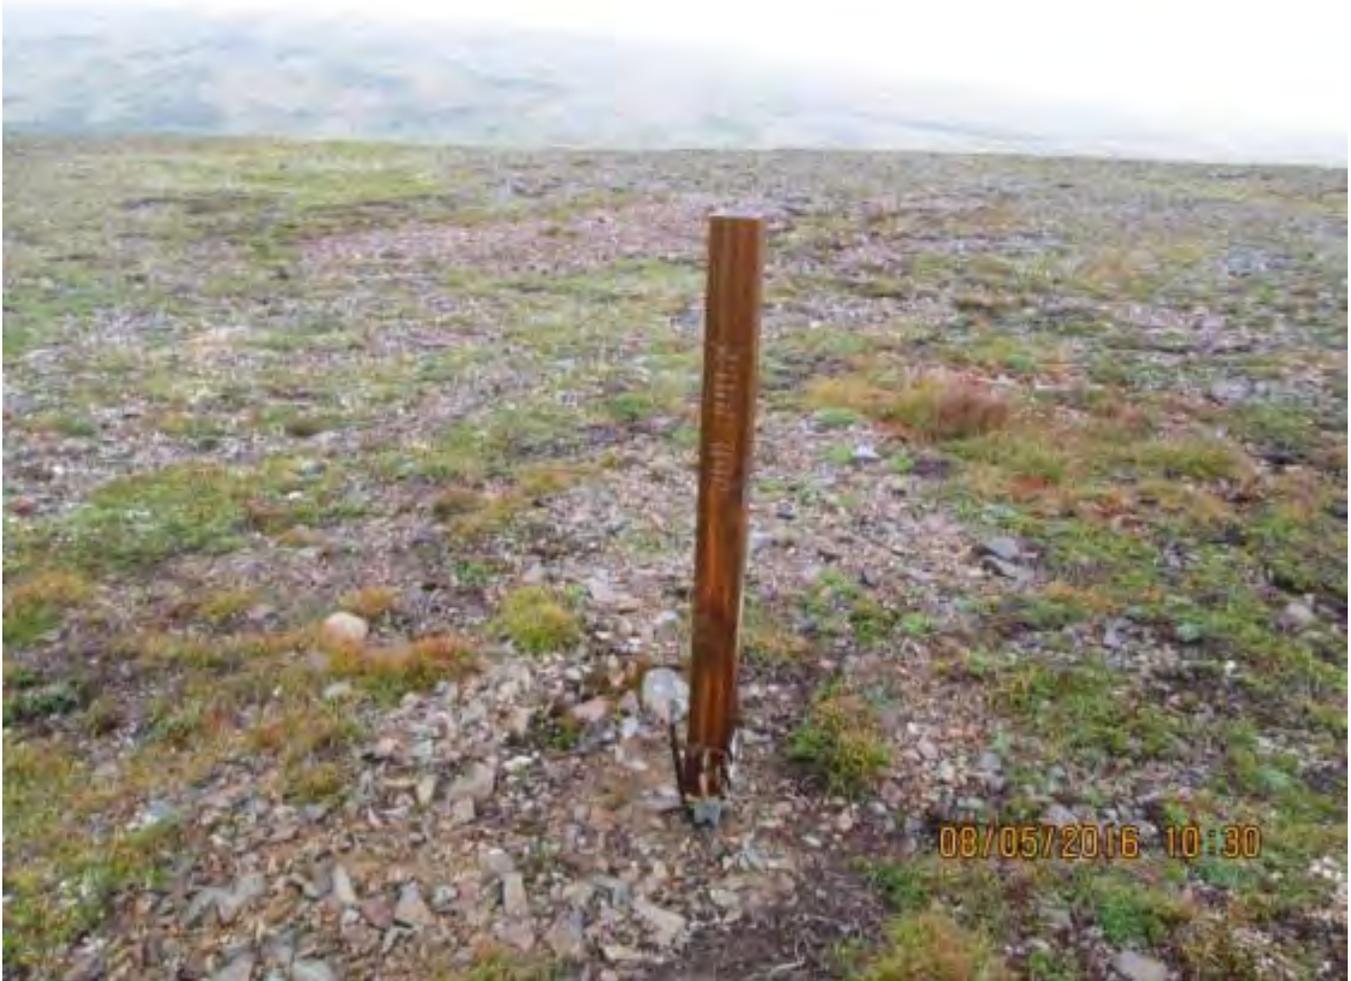
DDH 9452

This is an example of a fully reclaimed site with no apparent issues. No water was on the site.

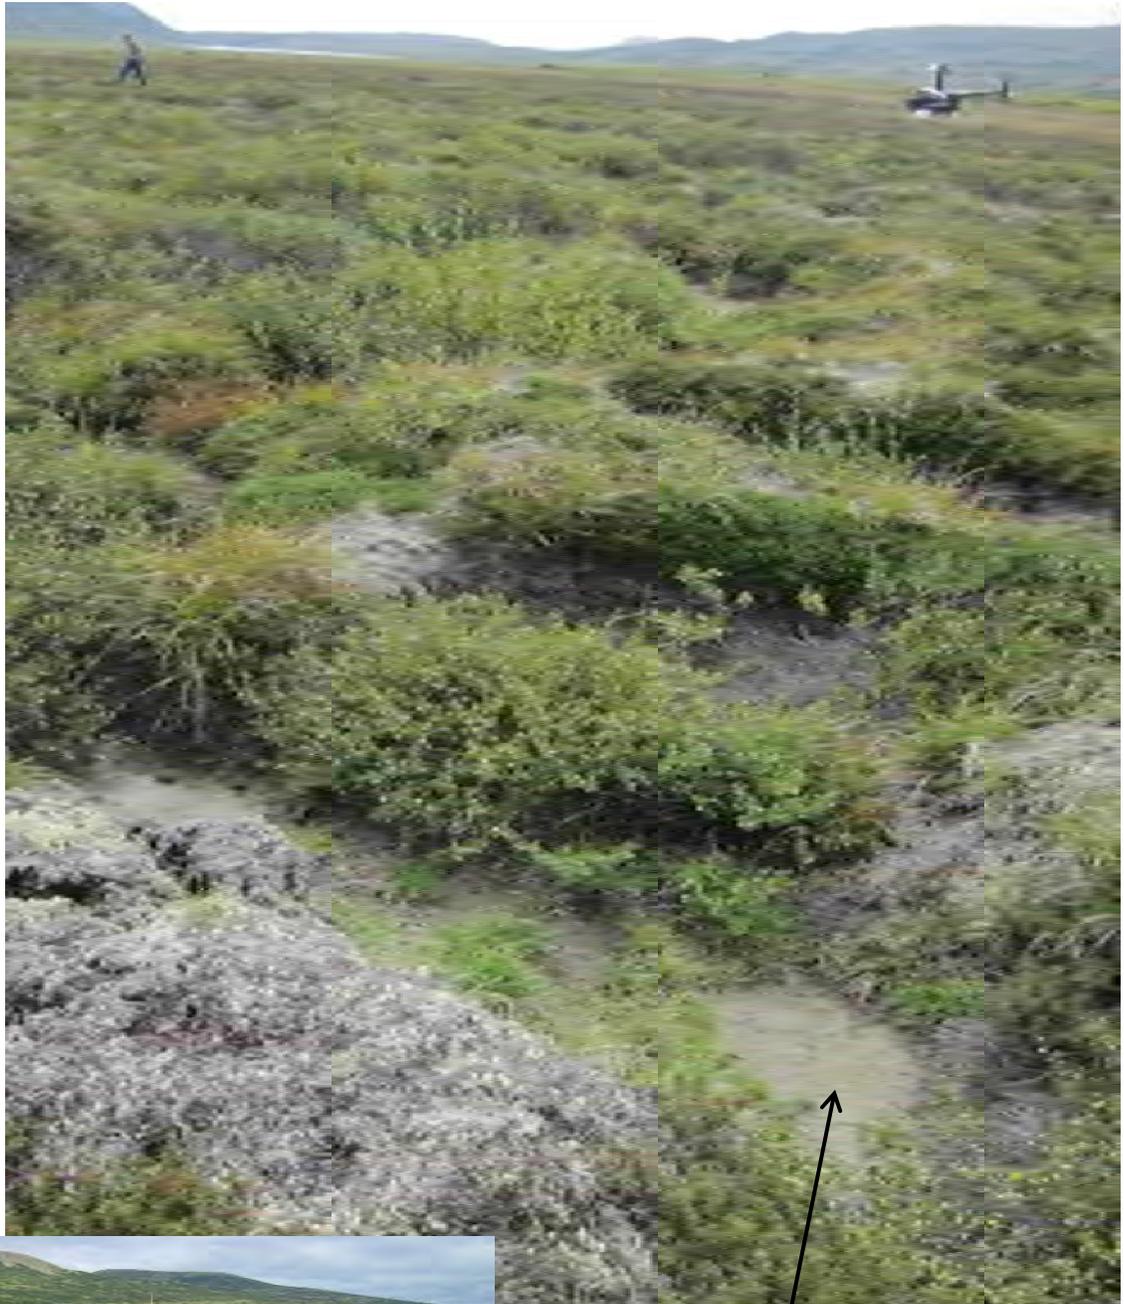
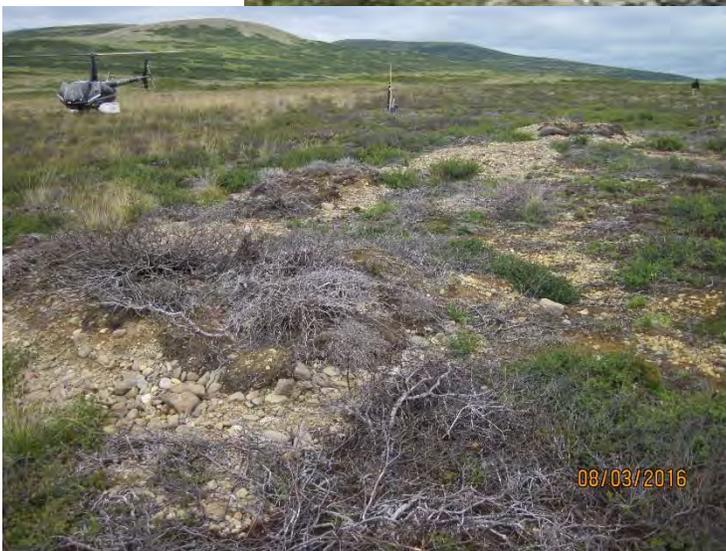
Patches of drill waste in small depressions

This is an example of one of three sites where drilling waste was disposed of over a large area in the past. Patches were located between DDH 12548 and DDH 4171. Vegetation was not growing on the drill sump pits at DDH 12548. Samples of soil with drill waste material were neutral pH but elevated in sulfate, copper, molybdenum and zinc (report Table 8).
