Documentation of Acidic Mining Exploration Drill Cuttings at the Pebble Copper–Gold Mineral Prospect, Southwest Alaska

Abstract: During exploration drilling of the Pebble copper–gold–molybdenum (Cu–Au–Mo) deposit, drilling wastes were disposed of directly on the landscape or passed through unlined sumps prior to disposal. The ore and host rock are rich in sulfides, which weather to sulfuric acid with consequent metal leaching. Oxidized cuttings were visually evident, and confirmed with laboratory and field testing to have a pH of 2.7–4.3. At these sites, Cu and Mo exceeded or were at the high end of the natural background. With one exception, Cu was in the range of 545 mg/kg to 4865 mg/kg. Dead vegetation was observed at all sites with drill cuttings on the surface. Dead vegetation was also observed on sump soil covers, unrelated to drilling waste. Sites where vegetation had not re-established were from four to thirteen years old. The potential impact to surface and groundwater was not determined. Understanding the source and extent of damage from cuttings could lead to better site management.

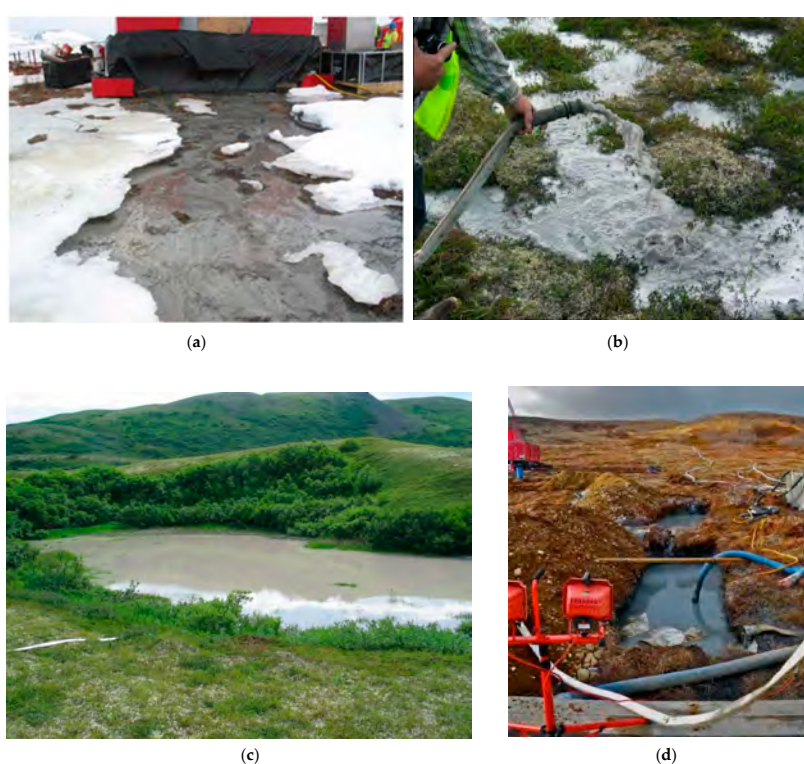
Figure 2. Drill waste discharged to land. (a) Direct discharge of drill waste, including drill cuttings. (b) Discharge of sump water. (c) Disposal of drill waste to kettle depression. Source: [4,5]. (d) Drill waste sump. Note that all waste sumps were unlined. Photo credit: M. Welker.

Drilling waste at Pebble was disposed of directly onto the landscape (Figure 2a–c) [4,5] or run through a series of unlined sumps to settle cuttings before pumping sump water onto the landscape for disposal (Figure 2d). Heavier material-like cuttings would sink in the sump, and are presumed to remain there; the sump was then covered with the initial soil mat that had been removed. Lining a sump would involve deploying and installing the liner, which is time consuming and expensive; as a result, liners are only occasionally used in sumps for drill cuttings, and were not utilized at this site.

Although sumps went into use in about 2003, drilling waste continued to be disposed of on land at times of the year or at locations where digging sumps was difficult. Some sumps were dug in wetlands. Large pumps were used when sumps were near water bodies to move sump wastewater by distances of up to 610 m to upland ponds and natural depressions such as kettles (Figure 2c). Kettles are depressions created by melting remnant glaciers. Ponds, which may be connected to groundwater, form in many kettles.

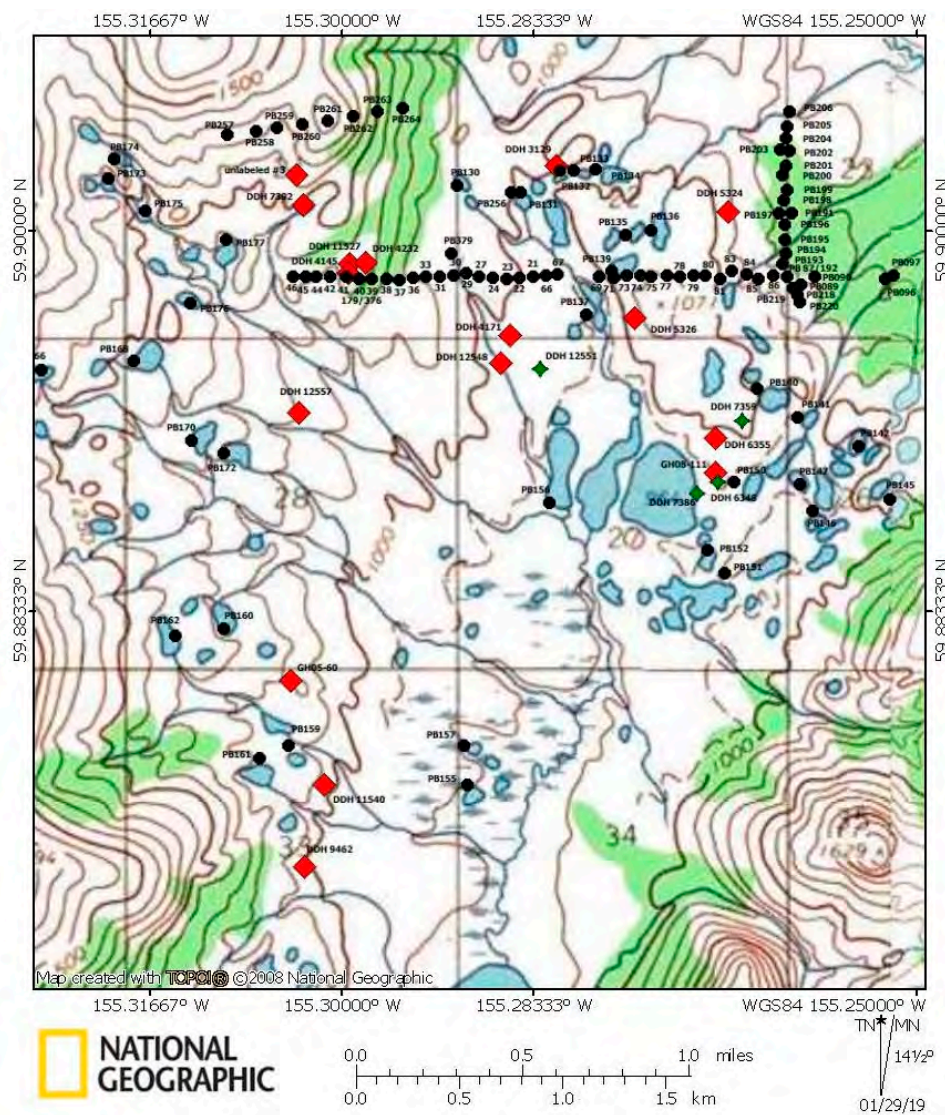
Figure 3. Topographical map. Selected sample sites. All 2016 soil sample sites discussed in this paper are shown. Red diamonds = sampled sites. Green diamonds = unsampled diamond drill hole (DDH) sites mentioned in this paper. Black circles = U.S. Geological Survey (USGS) sample sites used for comparison chemistries. USGS site PB180, where drill cuttings were collected, is not shown due to lack of space, but is located just downgradient of DDH 4232 along the USGS traverse line. Created by K. Zamzow with National Geographic Topo! software.

The exploration company, Pebble Limited Partnership (PLP), provided the Alaska Department of Natural Resources (ADNR) with a spreadsheet listing the 1355 drill-holes (Figure 3), along with the length of the borehole and locations. Target sites were chosen based on documented history of problems as shown in the PLP spreadsheet provided to ADNR or observations from the air once on site. Upon landing at a target site, we walked to nearby drill sites to optimize our time and introduce randomness into the type of drill site inspected, ensuring sites documented as having no history of problems were included.

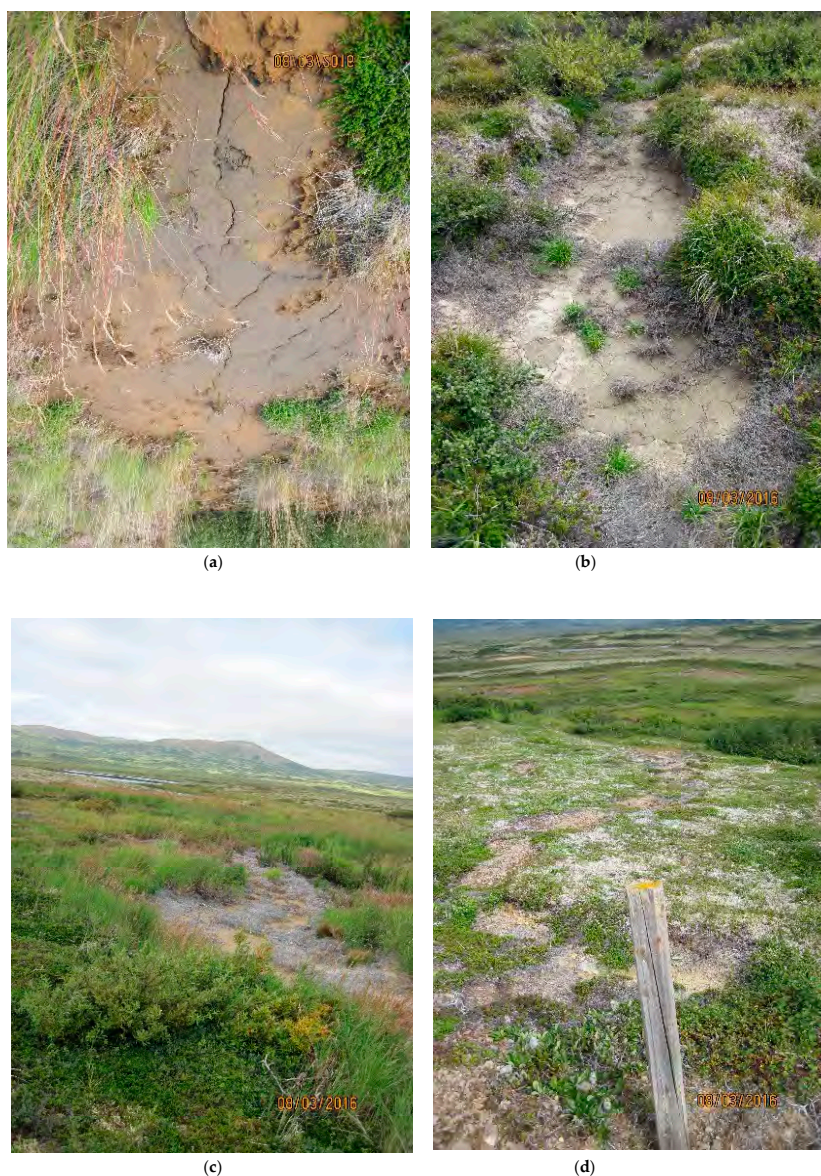
Figure 4. Oxidized and unoxidized cuttings from drill waste. Drill waste has a very fine texture and presents as either a gray color (unoxidized cuttings) or yellow–orange (oxidized cuttings). Drill waste was disposed of on land possibly 10–12 years prior to when these photos were taken in August 2016. (a) The fine texture and a mix of oxidized and unoxidized material, from widespread disposal near site DDH 6355, (b) Unoxidized cuttings, near site DDH 4145, (c) Swath of dead vegetation near DDH 6355, (d) Trail of drill cuttings from drill stem at DDH 4232. *Photo credit: K. Zamzow.*

Drill cuttings were visually distinct from background soils, with different texture and color and could sometimes be identified from the air. Cuttings were also observed at the base of some drill stems, suggesting potential intermittent flushing from down-hole, possibly during periods when the water table would rise (Figure 4).

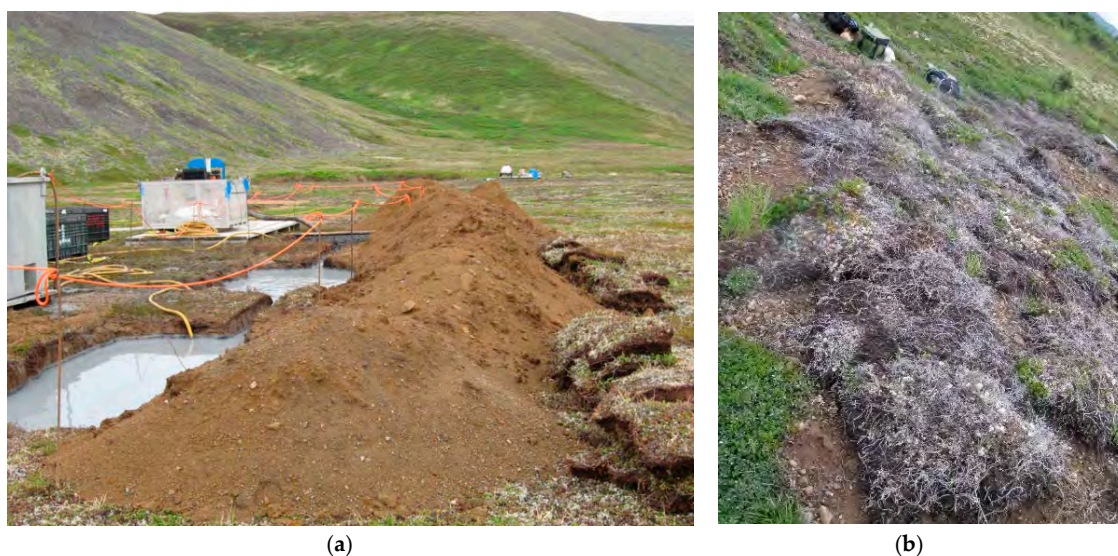
Figure 5. Reclamation of drill sumps. Many sumps could be clearly identified by the dead vegetation on the sump cover. (a) Sump in operation, with tundra mats set to the side for reclamation [7], (b) Sump cover 2016. Photo credit 2016 sump: K. Zamzow.

When a sump is dug, the overlying vegetation and soil are removed and set aside to be placed over the sump during reclamation. This is referred to here as “reclamation soil”, “tundra mat”, or “vegetation”. At many sites, the location of the sumps were evident by the lack of vegetation as a distinct rectangle covering them, despite no evidence of cuttings (Figure 5) [4,5,9]. Reclamation soil samples were collected at three sites (DDH 5324, DDH 11527, DDH 12557) to determine if there was chemical contamination. At site DDH11527, an attempt was made to retrieve drill waste in a sump. A hole was dug 2-feet deep into the cover of the sump and a 34-inch steel pipe was driven 24-inches further down (total depth, 47 inches). However, the core retrieved was the color and texture of reclamation soil, not drill waste.

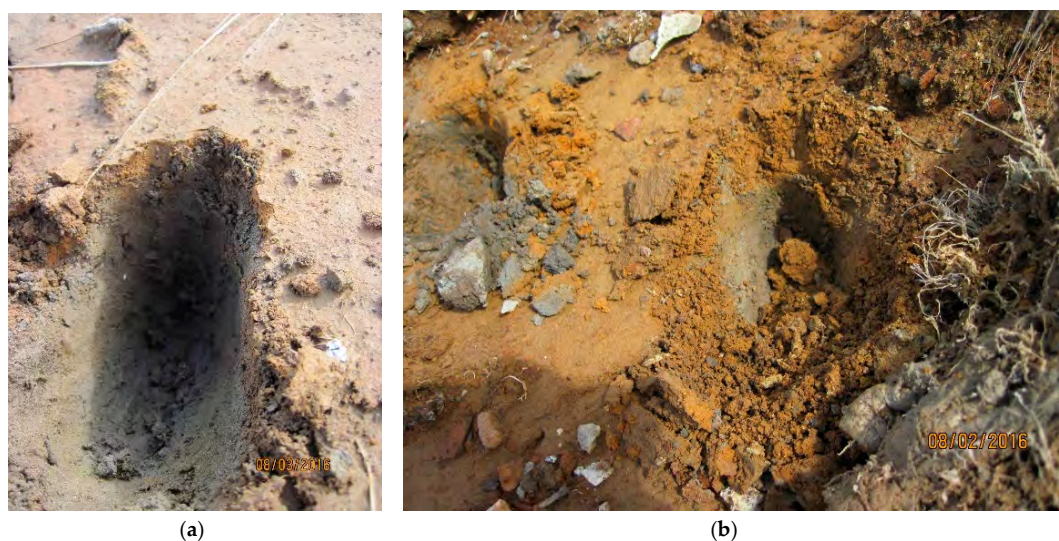
Figure 6. Drill waste samples. (a) Site DDH 6355. The upper oxidized layer, with a field pH of 2.9, was submitted for analysis. A mixture of upper and lower layers had a field pH of 5.3. (b) Site DDH 5326. The upper and lower layers when mixed had a field pH of 6.4; the sample was not submitted for analysis. *Photo credit: K. Zamzow.*

Five samples were acidic (DDH 6355, GH08-111, DDH 3129, DDH 7392, GH05-60) and three with only photos visually appeared to be oxidized (DDH 4145, DDH 4232, unlabeled site near DDH 7392). The sample at DDH 5326 had cuttings with classic oxidation on the surface and unoxidized

cuttings below (Figure 6); the field pH of the mixed layers was 6.4 and it appeared to be in the process of oxidizing.
