# Investigation and Documentation of Acidic Mining Exploration Drill Cuttings at the Pebble Copper–Gold Mineral Prospect, Southwest Alaska

## ABSTRACT

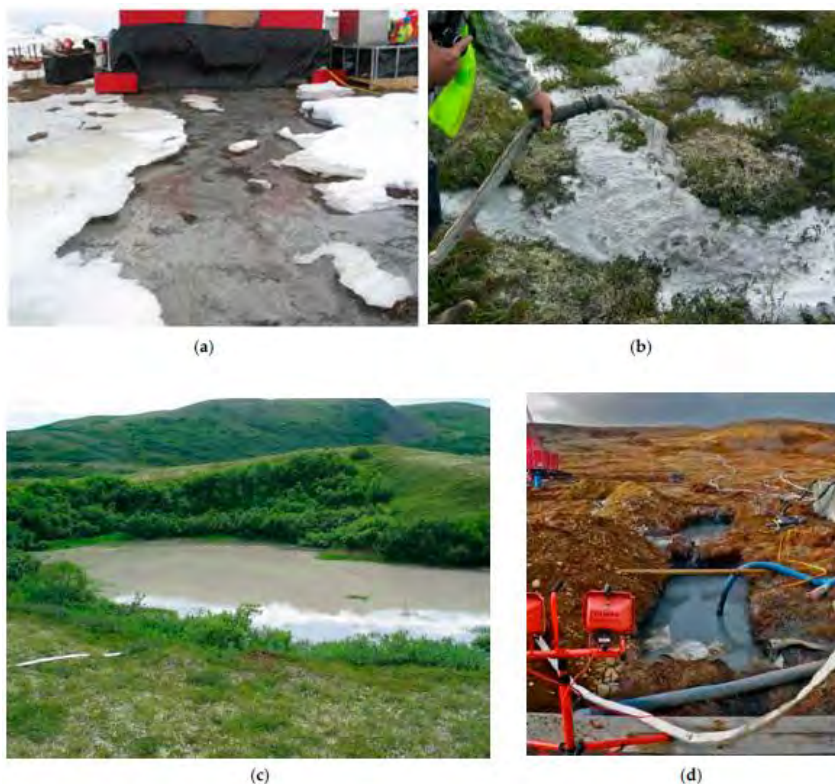
Drilling waste at Pebble was disposed of directly onto the landscape (Fig. 2a–c) [6,7] or run through a series of unlined sumps to settle cuttings before pumping sump water onto the landscape for disposal (Fig. 2d). Heavier material-like cuttings would sink in the sump, and are presumed to remain there; the sump was then covered with the initial soil mat that had been removed. Lining a sump would involve deploying and installing the liner, which is time consuming and expensive; as a result, liners are only occasionally used in sumps for drill cuttings, and were not utilized at this site.

**Fig. 2. Drill waste discharged to land. (a) Direct discharge of drill waste, including drill cuttings. (b) Discharge of sump water. (c) Disposal of drill waste to kettle depression. Source: [6,7]. (d) Drill waste sump. Note that all waste sumps were unlined**

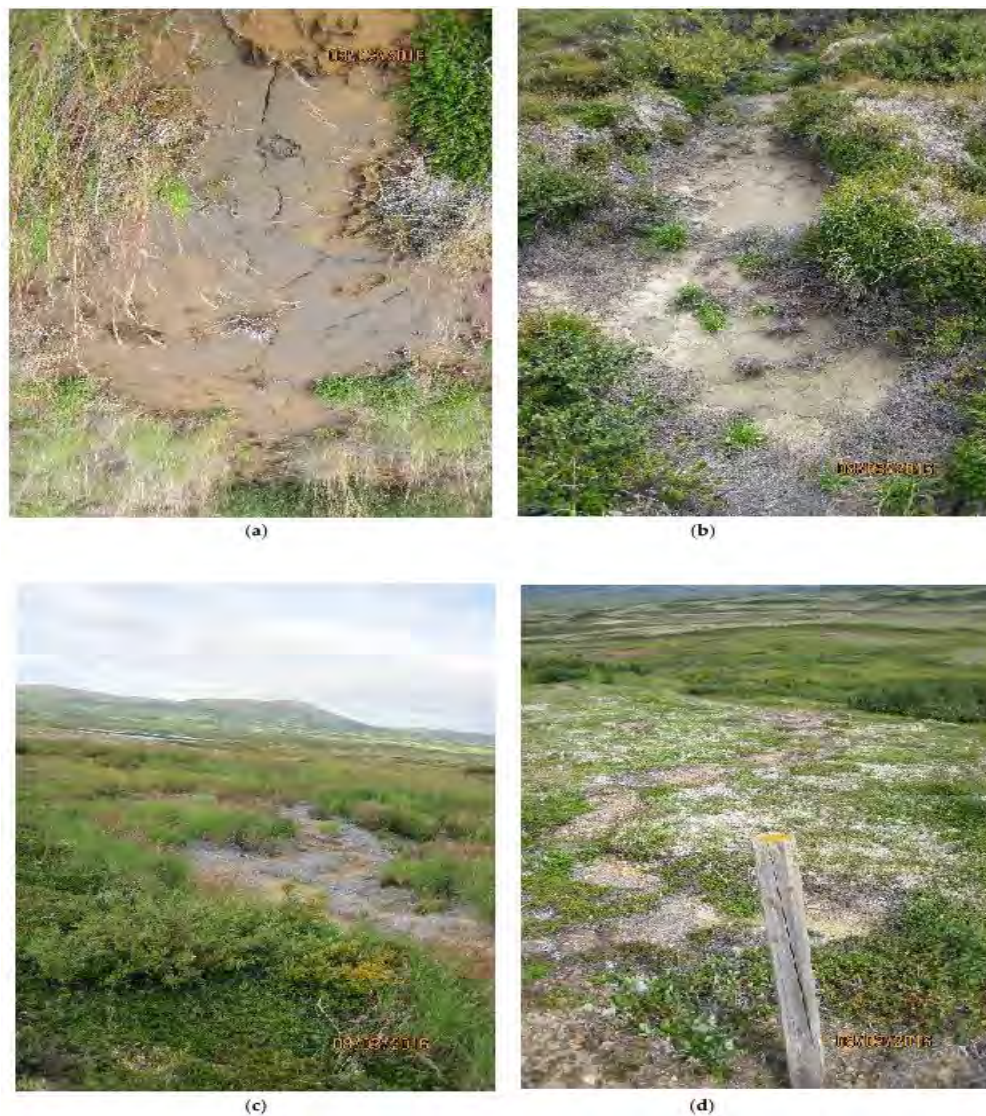
**Fig. 4. Oxidized and unoxidized cuttings from drill waste. Drill waste has a very fine texture and presents as either a gray color (unoxidized cuttings) or yellow–orange (oxidized cuttings). Drill waste was disposed of on land possibly 10–12 years prior to when these photos were taken in August 2016. (a) The fine texture and a mix of oxidized and unoxidized material, from widespread disposal near site DDH 6355, (b) Unoxidized cuttings, near site DDH 4145, (c) Swath of dead vegetation near DDH 6355, (d) Trail of drill cuttings from drill stem at DDH 4232**

Drill cuttings were visually distinct from background soils, with different texture and color and could sometimes be identified from the air. Cuttings were also observed at the base of some drill stems, suggesting potential intermittent flushing from down-hole, possibly during periods when the water table would rise (Fig. 4).

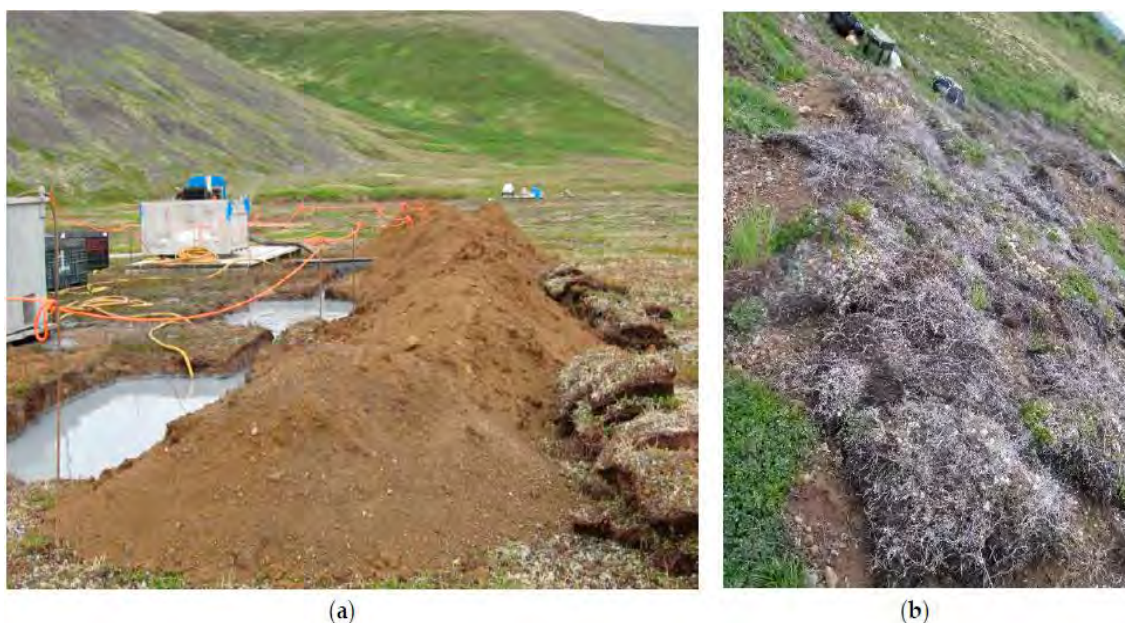
When a sump is dug, the overlying vegetation and soil are removed and set aside to be placed over the sump during reclamation. This is referred to here as “reclamation soil”, “tundra mat”, or “vegetation”. At many sites, the location of the sumps were evident by the lack of vegetation as a distinct rectangle covering them, despite no evidence of cuttings (Fig. 5) [6,7,11]. Reclamation soil samples were collected at three sites (DDH 5324, DDH 11527, DDH 12557) to determine if there was chemical contamination. At site DDH11527, an attempt was made to retrieve drill waste in a sump. A hole was dug 2-feet deep into the cover of the sump and a 34-inch steel pipe was driven 24-inches further down (total depth, 47 inches). However, the core retrieved was the color and texture of reclamation soil, not drill waste.

**Fig. 5. Reclamation of drill sumps. Many sumps could be clearly identified by the dead vegetation on the sump cover. (a) Sump in operation, with tundra mats set to the side for reclamation [9], (b) Sump cover 2016**

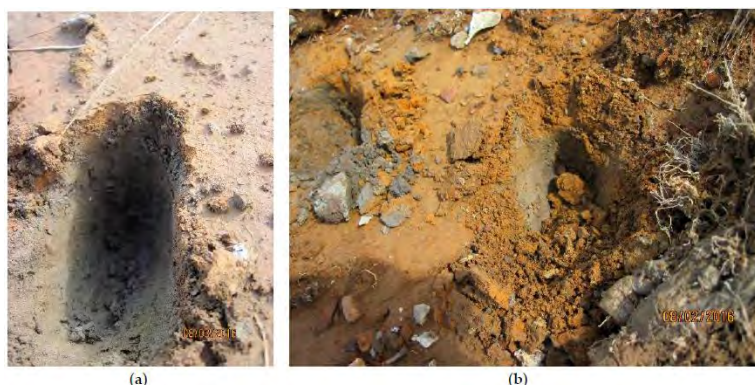
**Fig. 6. Drill waste samples. (a) Site DDH 6355. The upper oxidized layer, with a field pH of 2.9, was submitted for analysis. A mixture of upper and lower layers had a field pH of 5.3. (b) Site DDH 5326. The upper and lower layers when mixed had a field pH of 6.4; the sample was not submitted for analysis**

Five samples were acidic (DDH 6355, GH08-111, DDH 3129, DDH 7392, GH05-60) and three with only photos visually appeared to be oxidized (DDH 4145, DDH 4232, unlabeled site near DDH 7392). The sample at DDH 5326 had cuttings with classic oxidation on the surface and unoxidized cuttings below (Fig. 6); the field pH of the mixed layers was 6.4 and it appeared to be in the process of oxidizing.
