INVESTIGATION OF RECLAIMED DRILL SITES, PEBBLE PROSPECT, 2016

**Center for Science in Public Participation
for
United Tribes of Bristol Bay
304 Main Street
Dillingham, AK 99576
November 3, 2016**

Please cite the report as: Zamzow, K and D Chambers. 2016. Investigation of Reclaimed Drill Sites, Pebble Prospect, 2016. Kendra Zamzow, Ph.D., and David M Chambers, Ph.D., P. Geop., Center for Science in Public Participation, Bozeman, MT, for the United Tribes of Bristol Bay, Dillingham, AK, October, 2016.

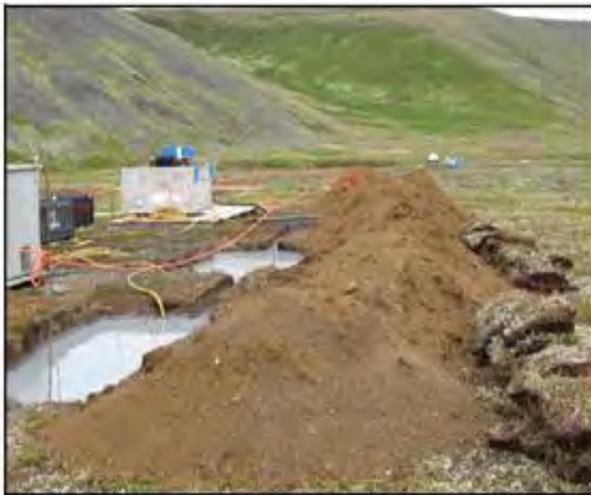
Figure 3. Sump pits (on left) and tundra stock pile being saved for reclamation (on right).

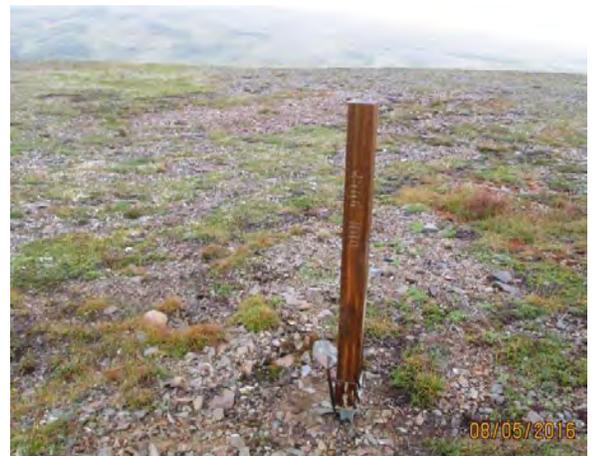
Figure 4. Monument marker. A wooden post with the drill hole number is commonly placed where the drill casing has been removed.

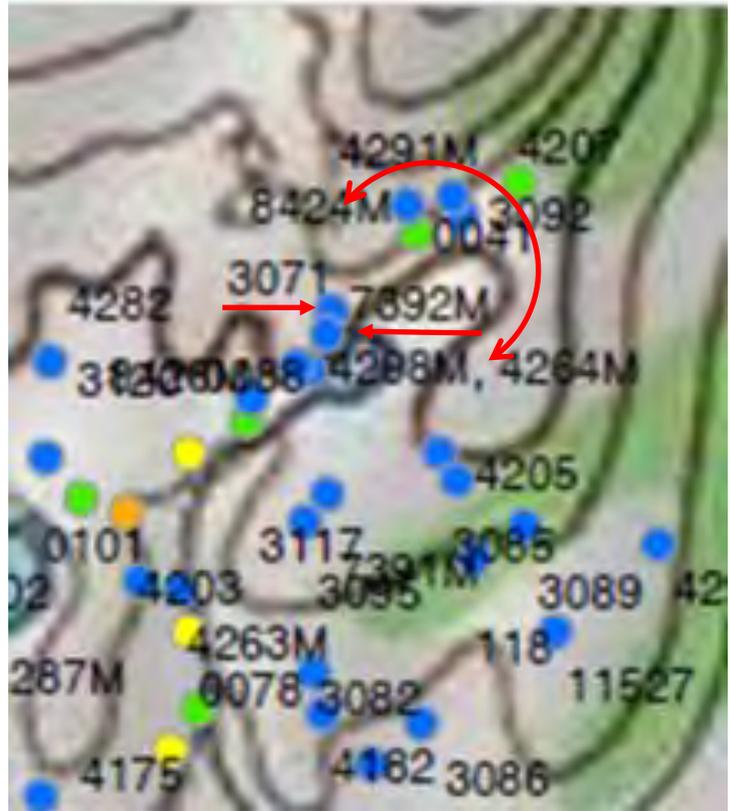
The site PB041, the discovery outcrop soil sample collected by USGS in 2007, is on a ridge west of and overlooking the main camp (Figure 9). This ridge is the site of at least six former drill sites, and rims a gulley that contains two abandoned drill sites, including DDH 7392 which has an open drill casing and has flushed a thick layer of drill cuttings along the gulley floor (Figure 8).

Figure 9. Topographic map of ridge and gulley. Drill sites 3071 and 7392M are in the bottom of the gulley. Multiple drill sites surround them along a horseshoe shaped ridge.

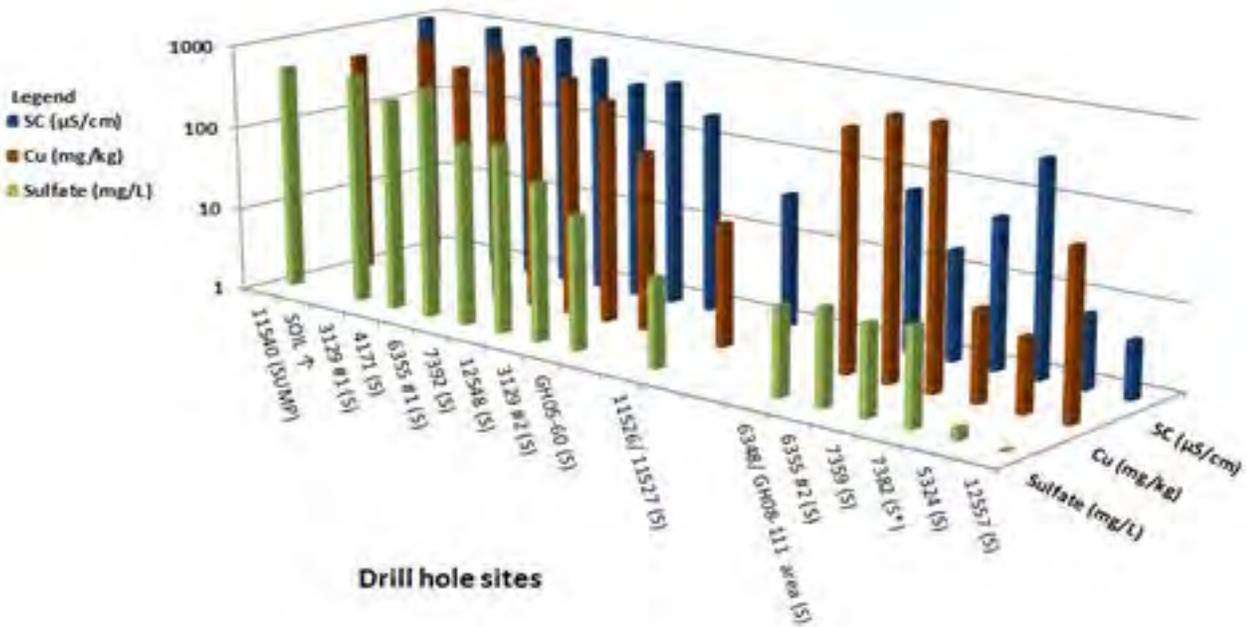
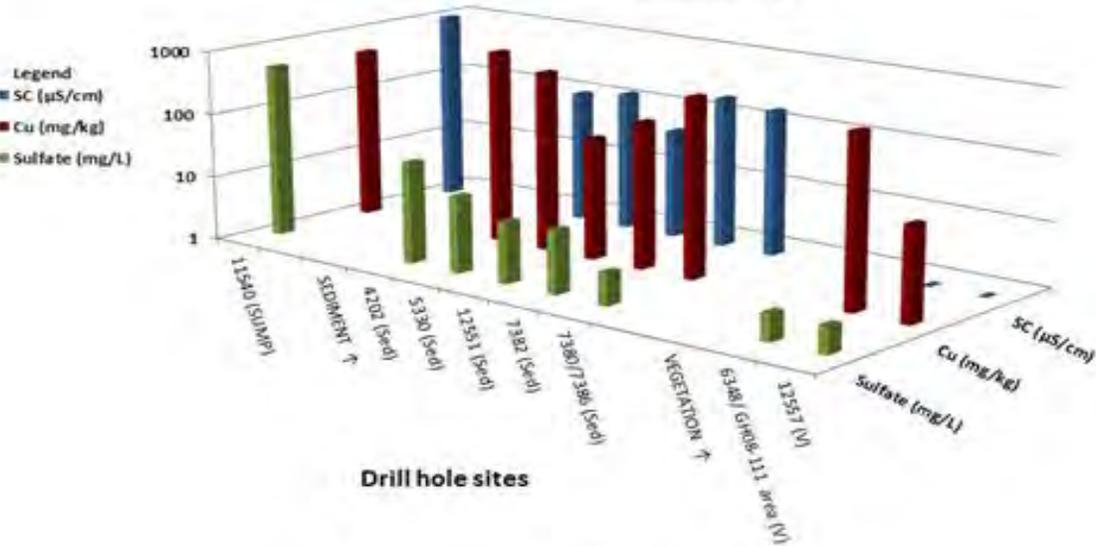
Figure 12. Soil, sediment, and vegetation chemistry. The chemistry associated with drill cuttings can be represented by the pattern of the drill sump material. (Top, label furthest to the left) Drill pit sump material is elevated in sulfate, copper, and specific conductance. Sites with drill cuttings have similar chemistry. The most dissimilar are sites on the far right. The sample of the upper 2" of soil from site DDH 6355 had a different profile than the sample from the upper 4". Site GH08-111, although in an area of drilling discharge, was a sample of grey material. The profile of sediment and vegetation (bottom), not impacted by drill cuttings, is different from soil in the upper figure. Drill sump material is shown on the far left of both charts for comparison.

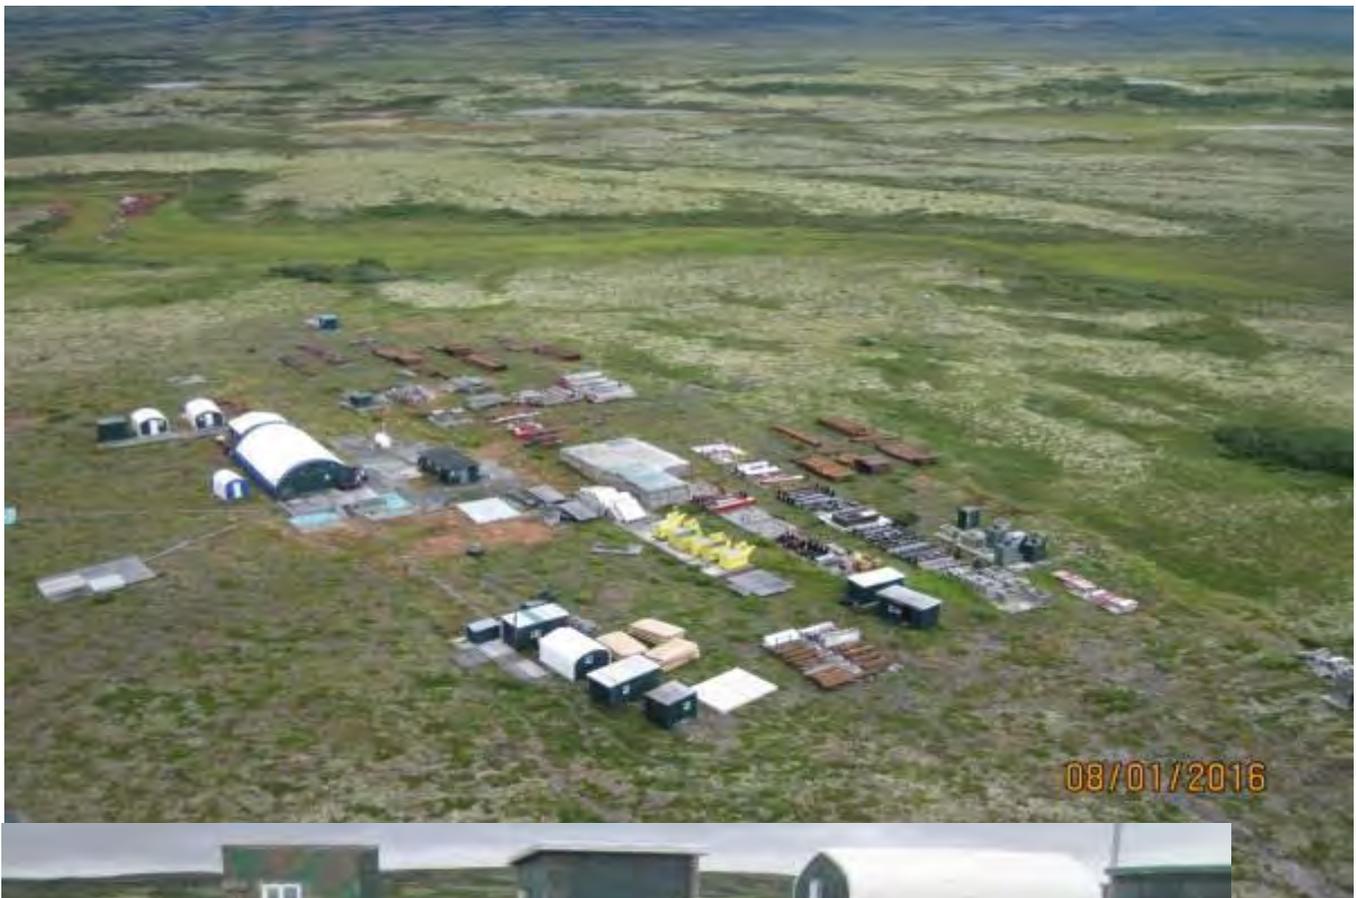
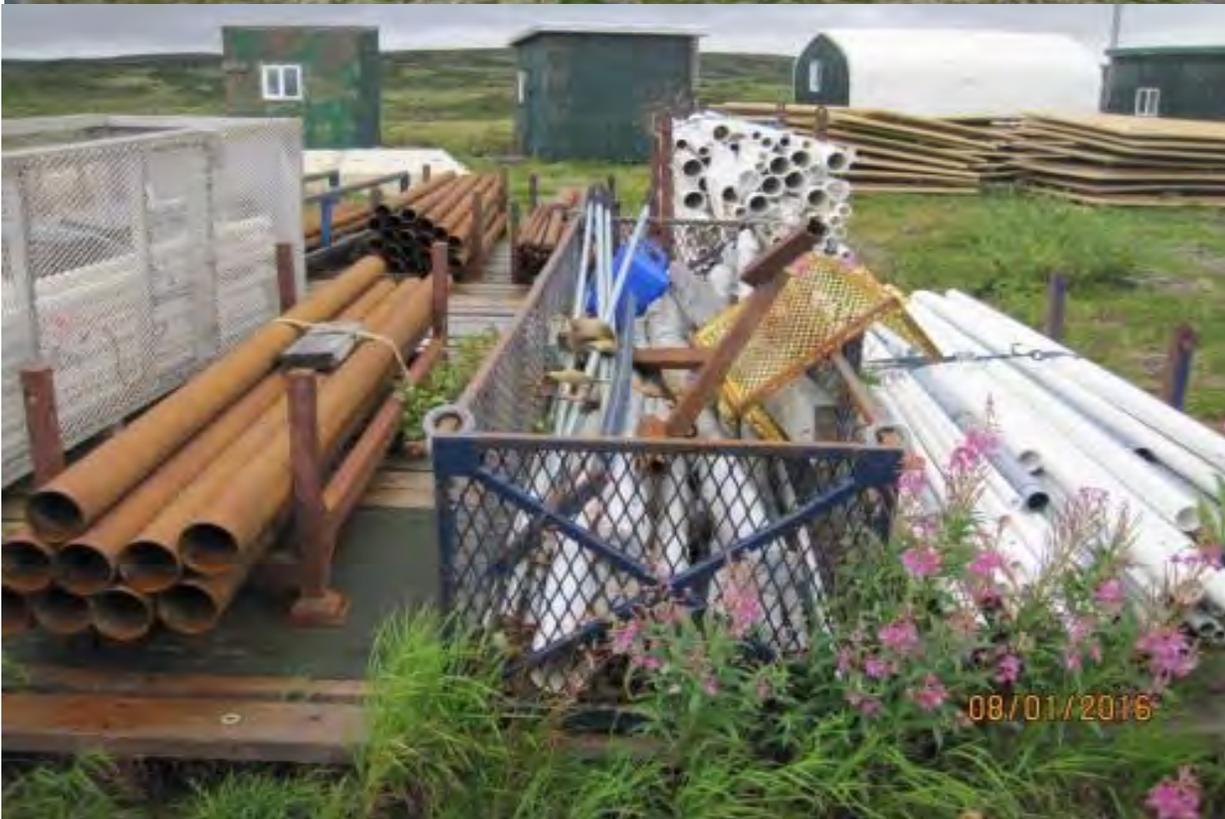
Main camp

The main camp contains drill pipe, buildings, tanks, and other supplies.
