The LOGBOOK of CSP²

CSP²/CSP²/CSP²/CSP²/CSP²/CSP²/CSP²/CSP²/ SUMMER 2017 /CSP²/CSP²/CSP²/CSP²/CSP²/CSP²/CSP²

Investigation of Pebble Prospect Reclaimed Drill Sites

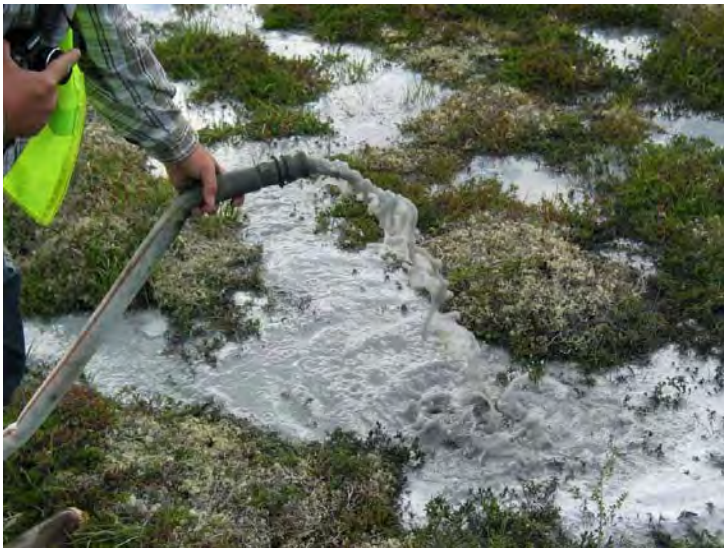
Figure 1: Drill discharge to tundra. (from ADNR Inspection Report, July 26-27, 2007)

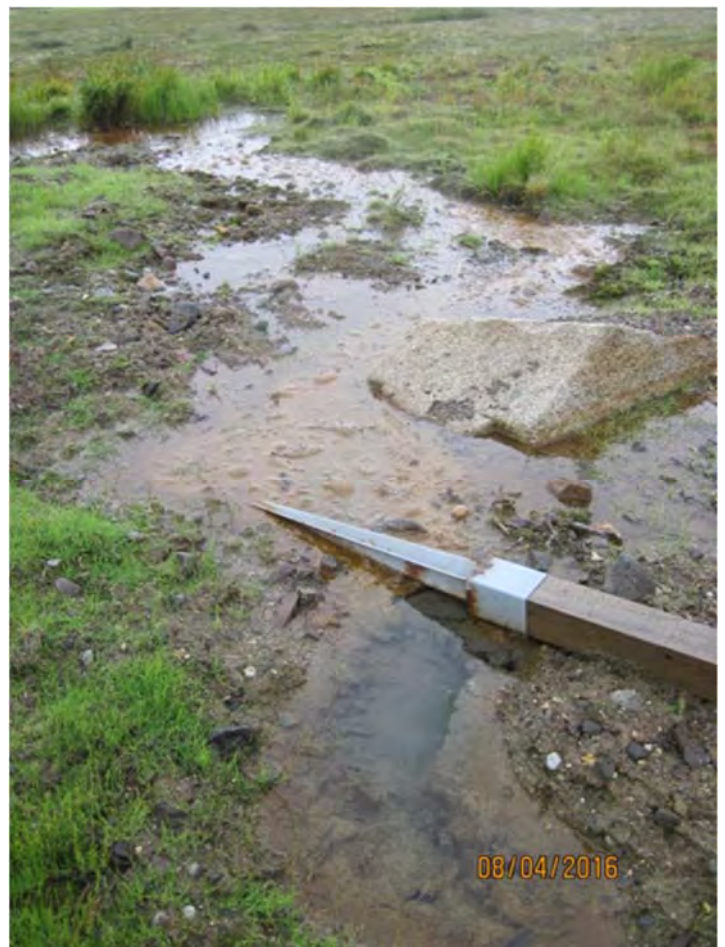
Artesian sites are producing water, neutral in pH, but elevated in metals. Artesian flow is occurring at loca-

tions with the drill casing both absent and present. ADNR listed six artesian sites for PLP to address but did not collect samples to determine what type of water was being discharged. CSP² sampled one of the six artesian sites ADNR visited and found it to be discharging aluminum, manganese, sulfate, sodium, calcium, and magnesium in high concentrations, but was low in copper (Figure 2). Of five artesian sites CSP² had tested, two were very high in copper, iron, and at least six other metals, with copper being well into the range of being toxic to aquatic life.

Figure 2: Artesian flow at DDH 9475, drilled in 2009.

Some sites that clearly have been artesian have temporary fixes. It is not clear why temporary fixes have been applied instead of removing the drill casing, as required by ADNR. At least two of these sites, repaired in 2015, were visited by ADNR and approved as “good condition”, with aerial photographs provided. Photographs on the ground (CSP2) indicate that sites are not permanently stable.

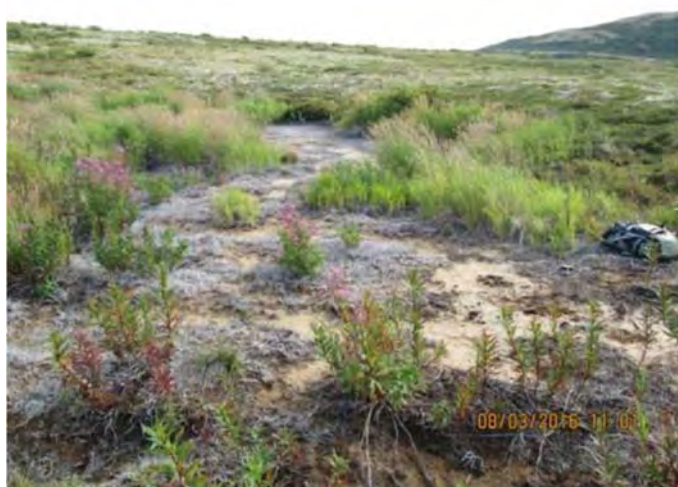
Remnants of direct discharge from drilling are still evident on the landscape as oxidized or grey fine-grained material accompanied by dead brush and tundra (Figure 3). Exploration drilling targeted sulfide ore with copper, gold, and molybdenum, and sampling by CSP2 determined sites with remaining drill waste discharge to be very high in copper and molybdenum. Some samples were acidic, and may be continuing to impact vegetation.

Figure 3: Dead vegetation and acidic drill cuttings (light-colored material in foreground) remain years after the hole was drilled. Soil was over 100 times higher in copper and molybdenum than background. The nearest hole (DDH 6355) was drilled in 2006.

Five areas with discharge were located. The nearest sites to these discharges were drilled in 2004, 2006, 2007, and 2012, indicating that the waste may have been impacting vegetation and soil for anywhere from 4 to 12 years.

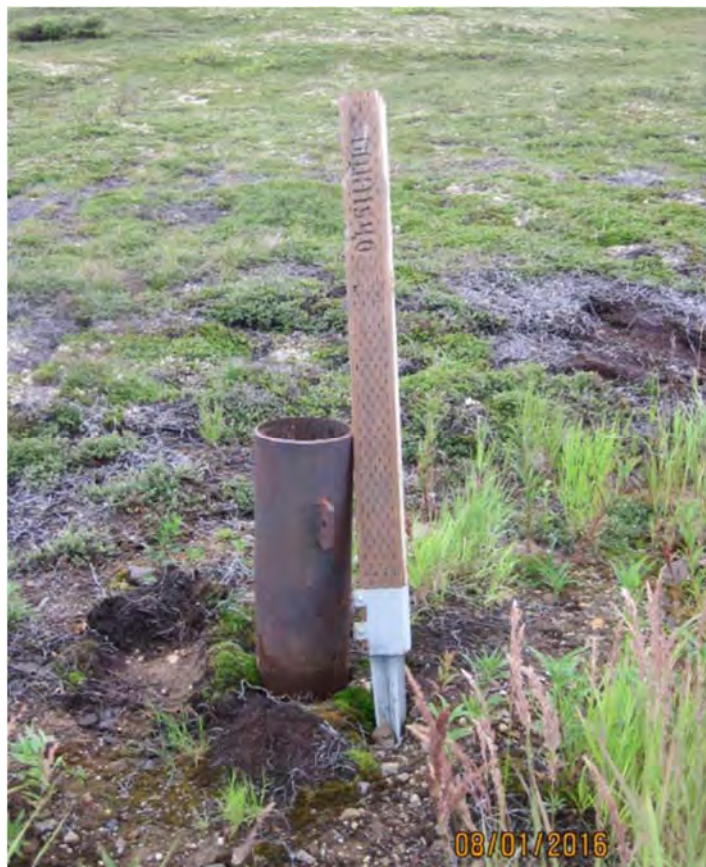
Approximately 25% of the sites visited had steel drill casings extending above the surface. These drill casings can pose a risk to snow machine operators

Figure 4: Steel drill casing at reclaimed drill site DDH 11540, drilled in 2011.

There were many sites that had open drill casings (Figure 4), and sites where drill casings had been removed but artesian water appeared to flow from the old drill hole. Mobilizing equipment to properly remove these drill casings and close the holes will be very expensive due to the remoteness of the location.

when fully or partially covered with snow. The Multiple Land Use Permit that ADNR issued to allow Pebble mine exploration on State land requires specific reclamation actions, including cutting abandoned drill casings off below ground surface, filling drill holes with a minimum of 10 feet of cement, removing equipment and buildings, and submitting an annual reclamation statement.
